# Inspection Report

## Sample Report

**Property Address:**  
1000 Sample Report  
Douglasville GA 30134

Precise Inspection Group

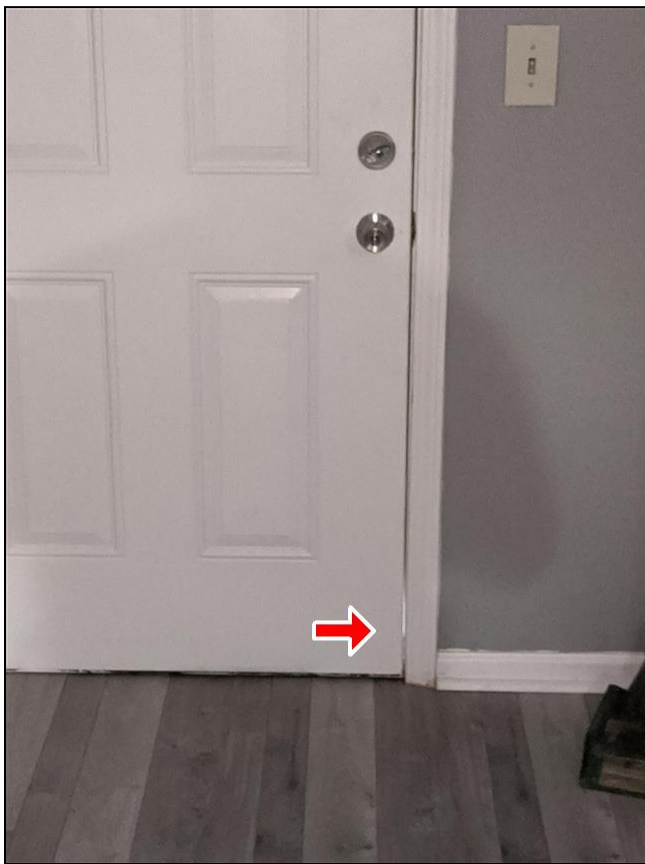
2.1 Item 1(Picture)

**2.1** (1) The side entry door (basement) reveals daylight when latched at areas missing weather-stripping. This is a maintenance issue and is for your information. .

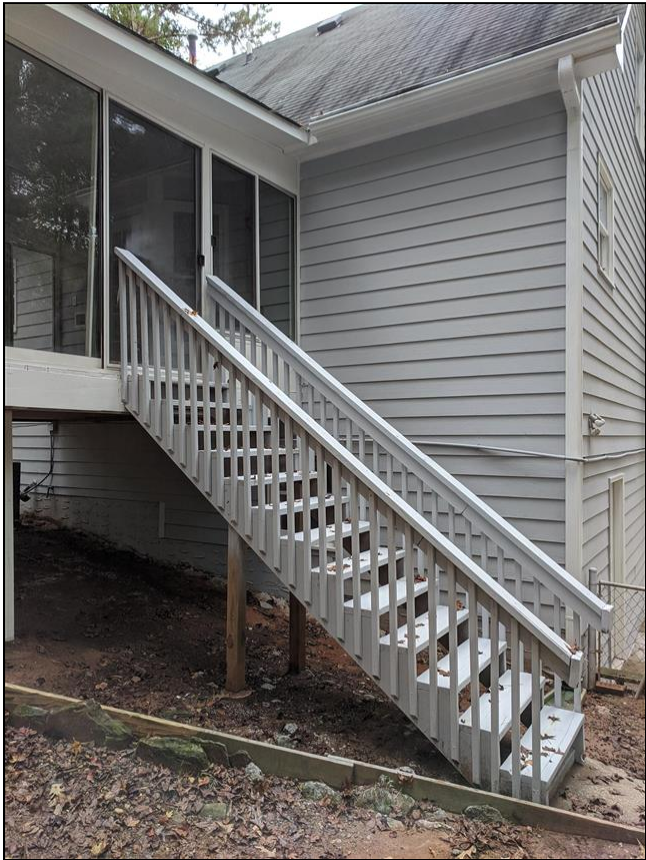
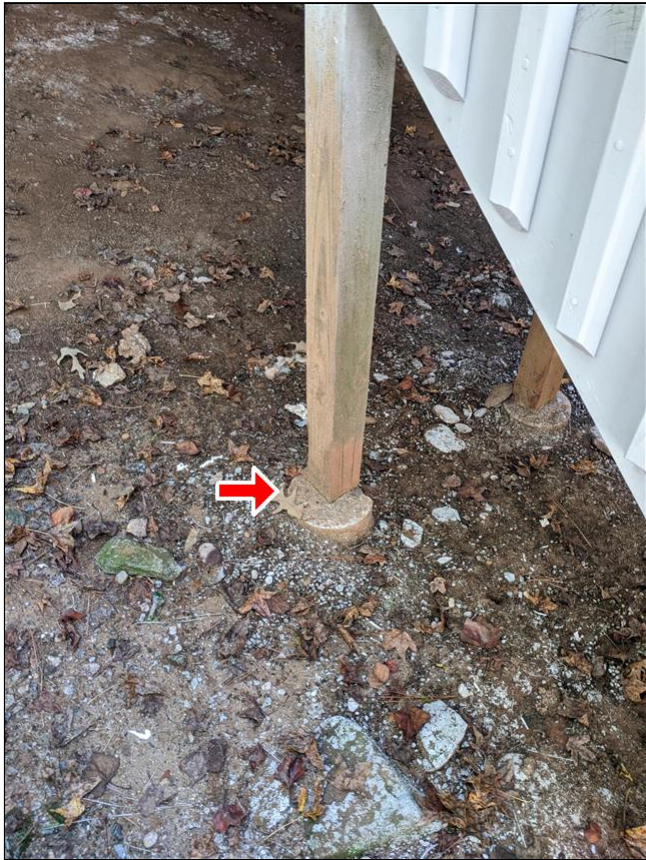
2.3 Item 1(Picture)

2.3 The deck post is loose and not secured properly. An injury can occur if not corrected due to further deterioration. A qualified contractor should inspect further and repair as needed.

The deck post is loose and not secured properly. An injury can occur if not corrected due to further deterioration. A qualified contractor should inspect further and repair as needed.

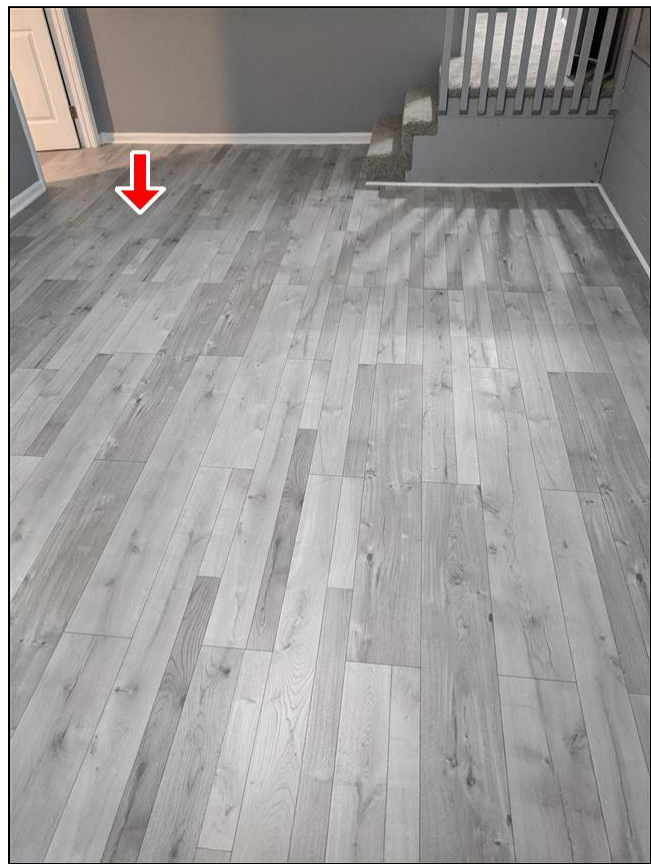
3.2 Item 1(Picture)

3.2 The Laminate Flooring is loose in areas in the Basement. This is a cosmetic issue for your information. A qualified person should repair or replace as needed.

The Laminate Flooring is loose in areas in the Basement. This is a cosmetic issue for your information. A qualified person should repair or replace as needed.

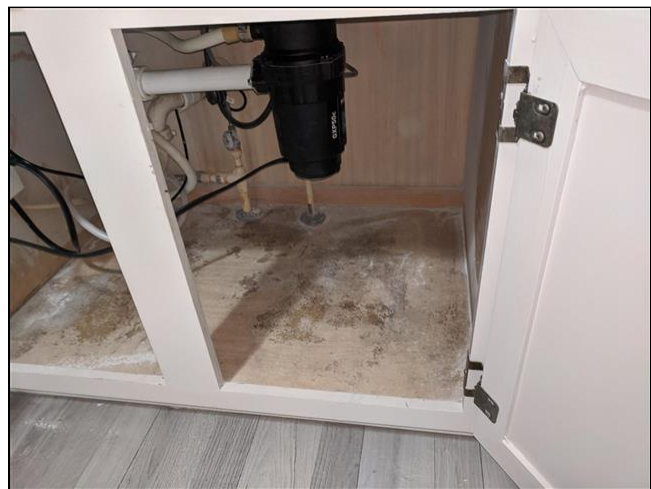
3.4 Item 1(Picture)

3.4 Kitchen sink base showed signs of previous leaks. No active moisture was detected.

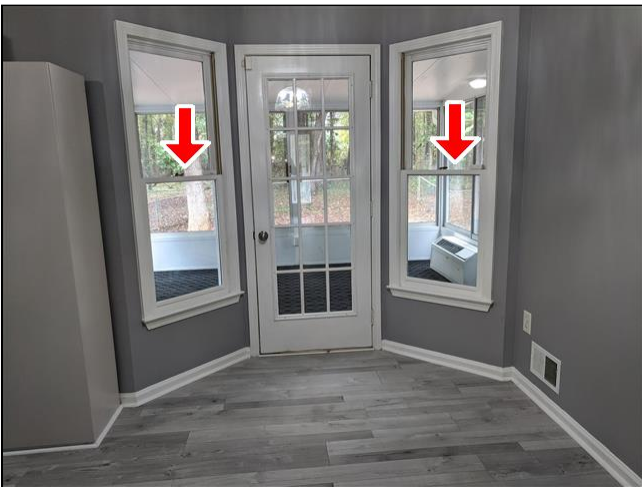
3.6 Item 1(Picture)

**3.6** (1) Two windows stuck or painted shut at the Kitchen. This is a small repair. A qualified contractor should inspect and repair as needed.

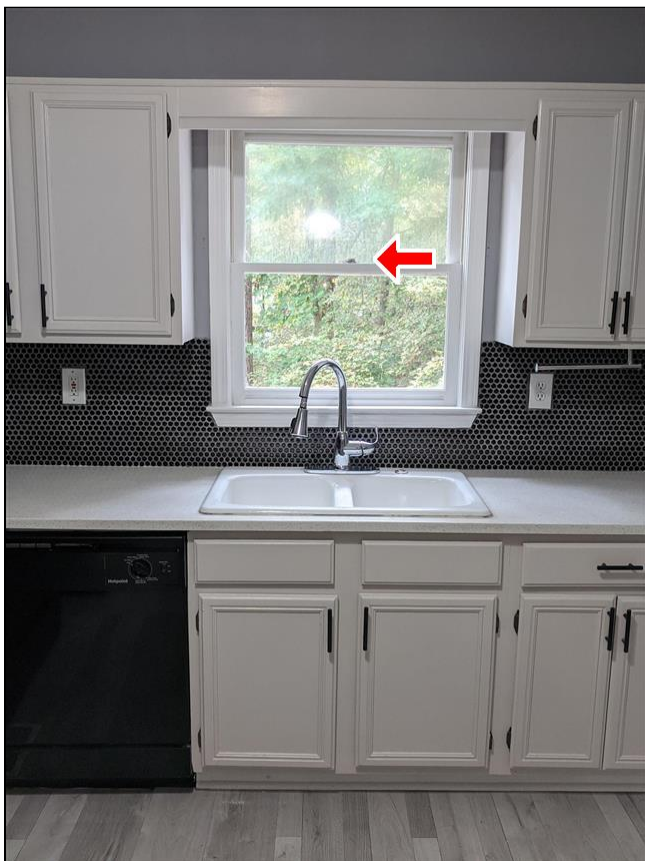
3.6 Item 2(Picture)

(2) One window is damaged at handle or lock hardware at the Kitchen. I recommend repair as desired.

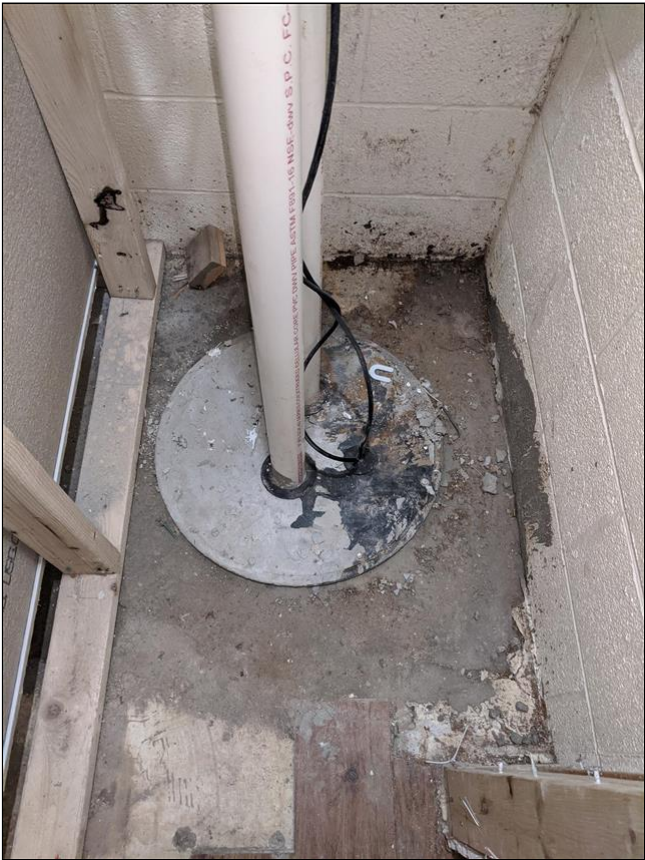
4.0 Item 1(Picture)

4.0 Visible signs of water intrusion in the basement is present from standing waster observed on floor. Although this appears to be a cosmetic issue, I recommend monitor frequently before contacting a qualified licensed contractor or water infiltration specialist.

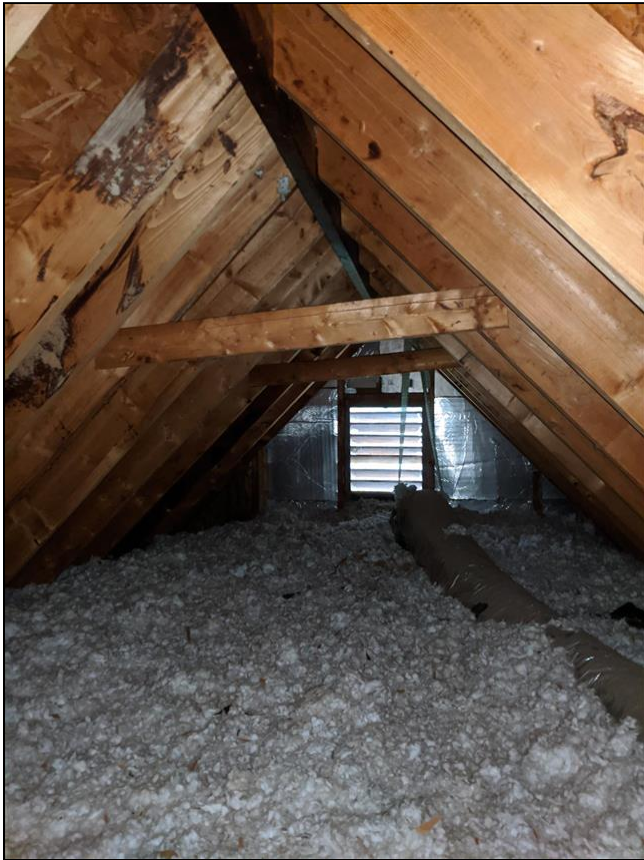
4.5 Item 1(Picture)

**4.5** Signs of moisture was observed from a previous leak at roof. Repairs appeared to be properly performed. No moisture was detected. Monitor as needed.

Signs of moisture was observed from a previous leak at roof. Repairs appeared to be properly performed. No moisture was detected. Monitor as needed.

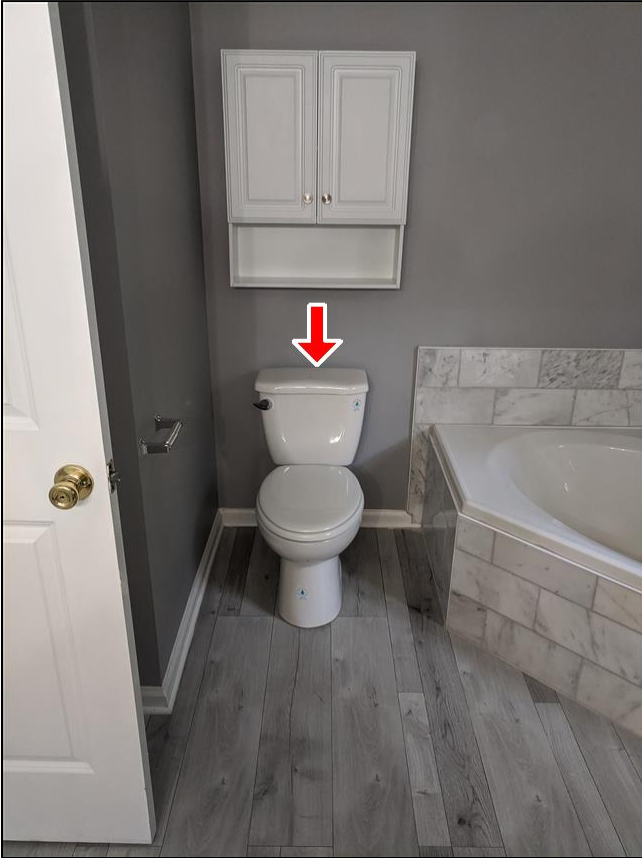
5.0 Item 1(Picture)

**5.0** (1) The toilet is loose at the Bathroom on the Main Level. Repairs may involve re-setting the toilet on a new wax seal. I recommend a qualified licensed plumber repair or correct as needed.

(1) The toilet is loose at the Bathroom on the Main Level. Repairs may involve re-setting the toilet on a new wax seal. I recommend a qualified licensed plumber repair or correct as needed.

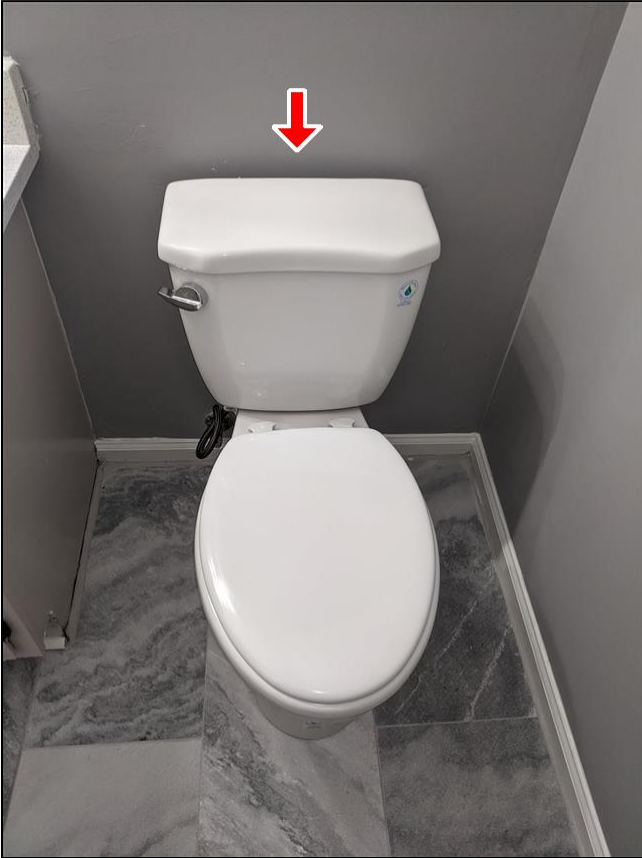
5.0 Item 2(Picture)

(2) The toilet is loose at floor at the Guest Bathroom on 2nd Floor. Repairs may involve re-setting the toilet on a new wax seal. I recommend a qualified licensed plumber repair or correct as needed.

(2) The toilet is loose at floor at the Guest Bathroom on 2nd Floor. Repairs may involve re-setting the toilet on a new wax seal. I recommend a qualified licensed plumber repair or correct as needed.

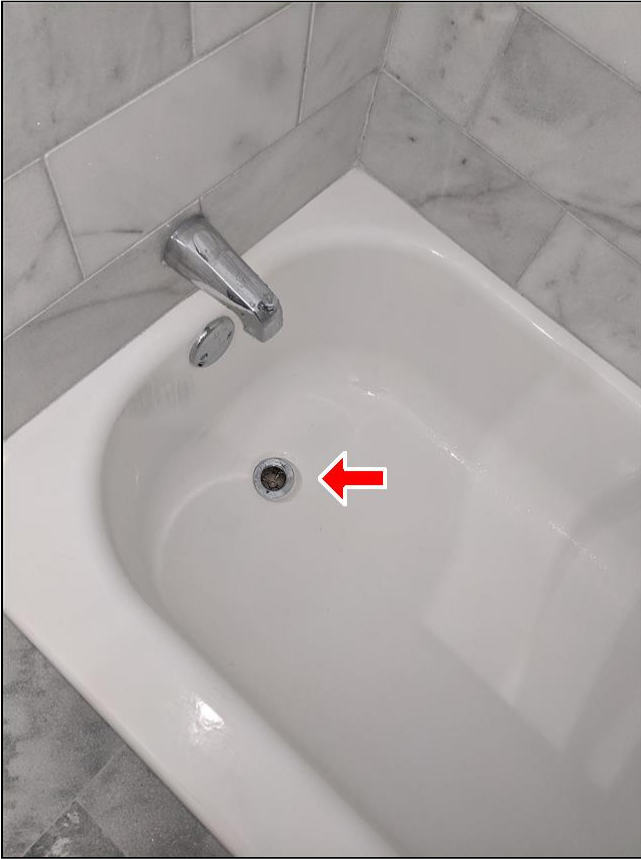
5.1 Item 1(Picture)

5.1 The Guest Bathtub on 2nd Level is missing drain-stopper. Replace as needed.

The Guest Bathtub on 2nd Level is missing drain-stopper. Replace as needed.

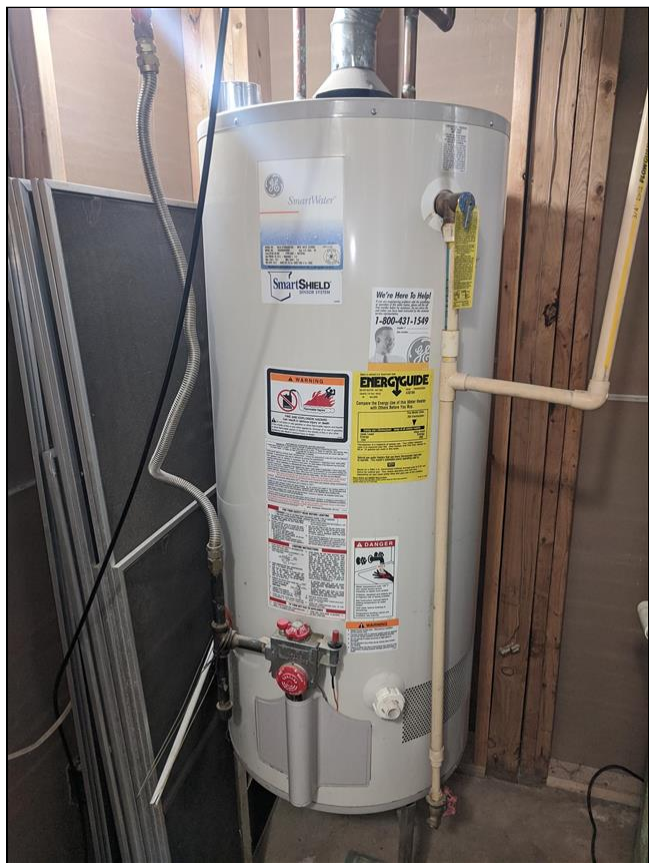
5.2 Item 1(Picture)

5.2 The GE Water Heater has a manufacturing date of : July 2005

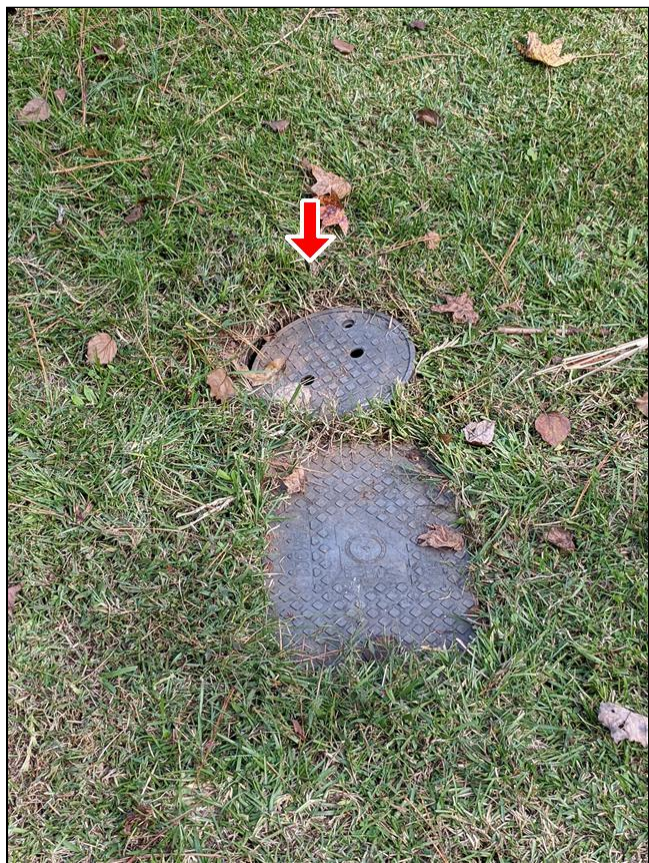
5.3 Item 1(Picture)

5.3 The main shut off is located outside in the ground.

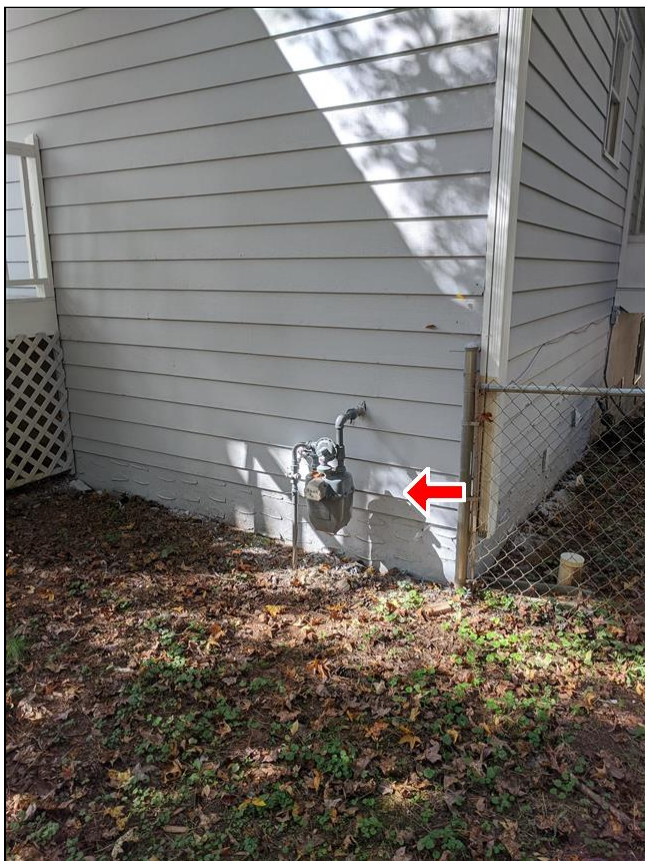
**5.5** Item 1(Picture)

**5.5** The main fuel shut off is at gas meter outside

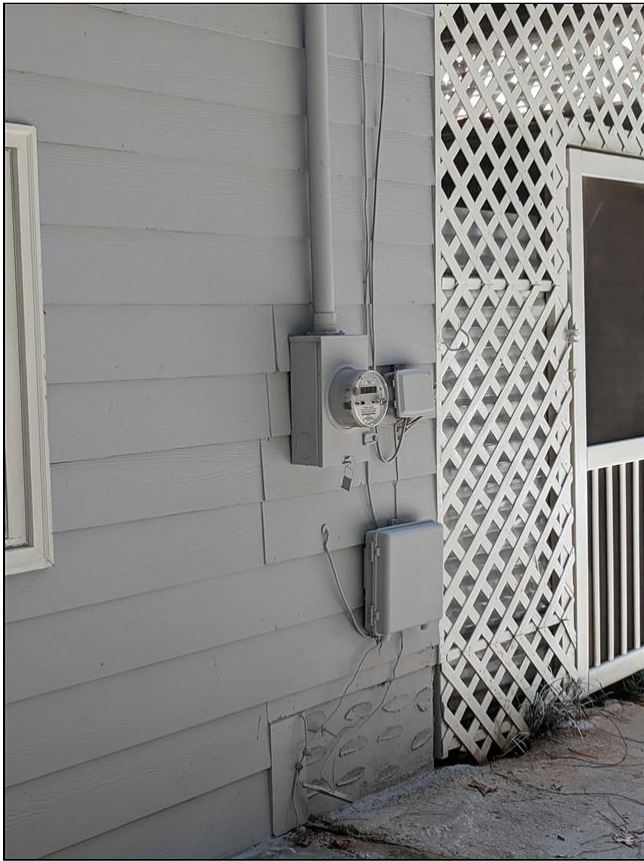
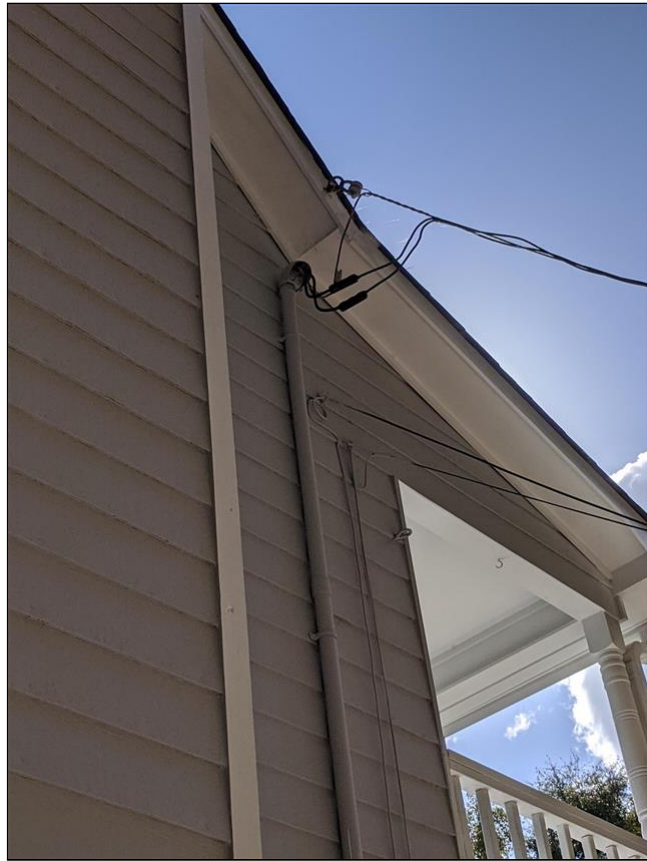
6.0 Item 1(Picture)

6.0 Home has above-ground power lines

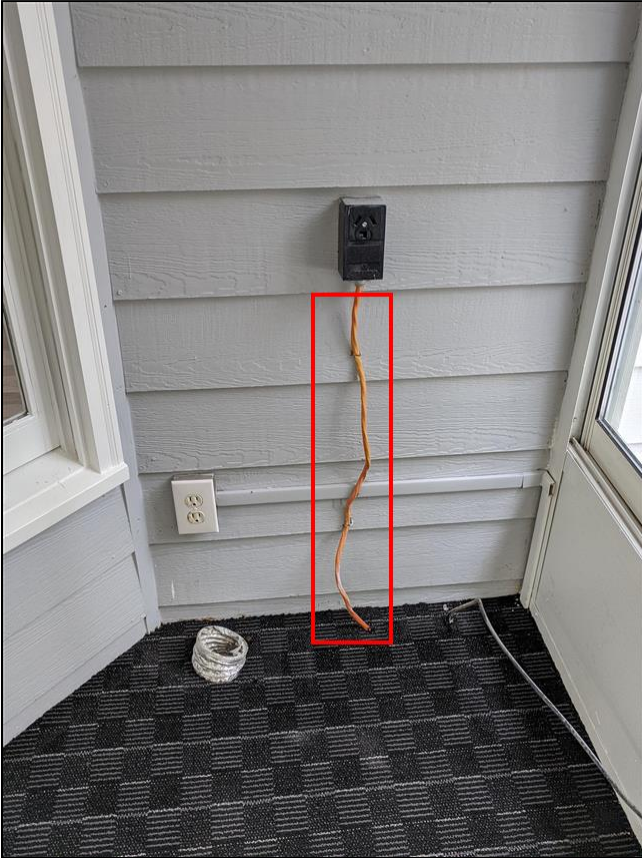
6.3 Item 1(Picture)

**6.3** (1) Exposed wiring at the Dryer (clothes dryer connections) on wall. A qualified licensed electrical contractor should correct as needed.

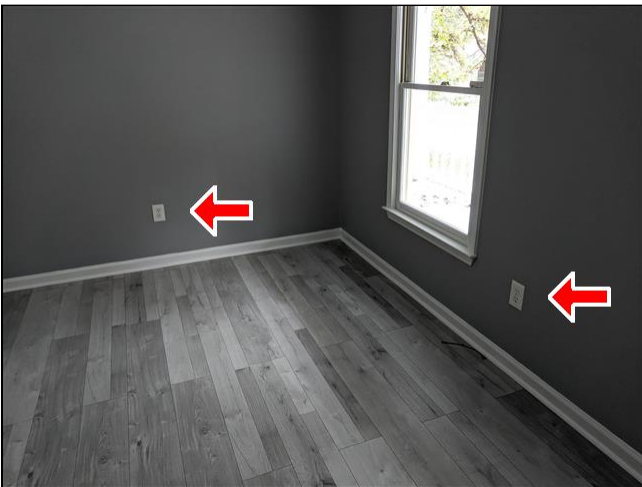
6.3 Item 2(Picture)

(2) At least two "three-prong" outlets are loose in wall in the bedroom on Main Level. . I recommend repair as needed.

(2) At least two "three-prong" outlets are loose in wall in the bedroom on Main Level. . I recommend repair as needed.

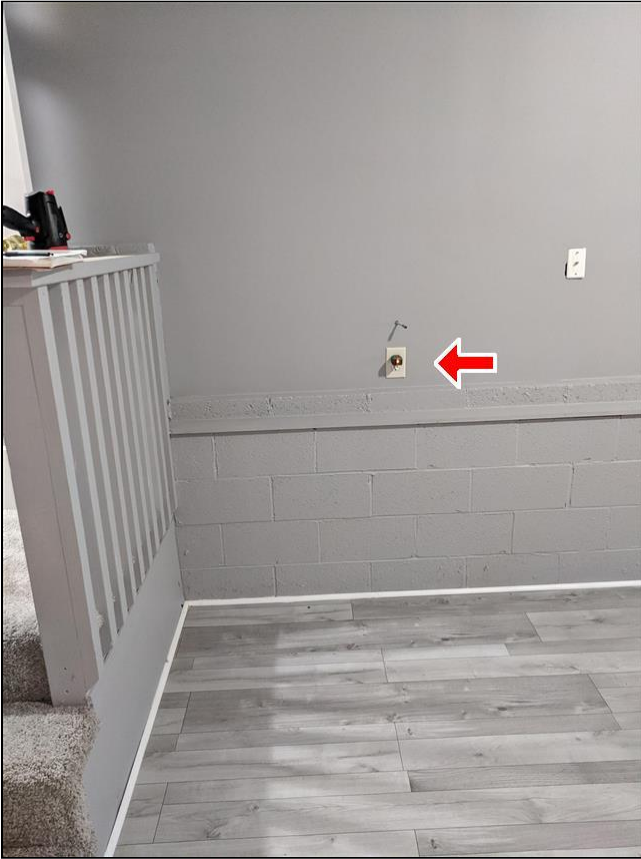
6.3 Item 3(Picture)

(3) One outlet not grounded in basement. I recommend repair as needed by a qualified electrician.

(3) One outlet not grounded in basement. I recommend repair as needed by a qualified electrician.

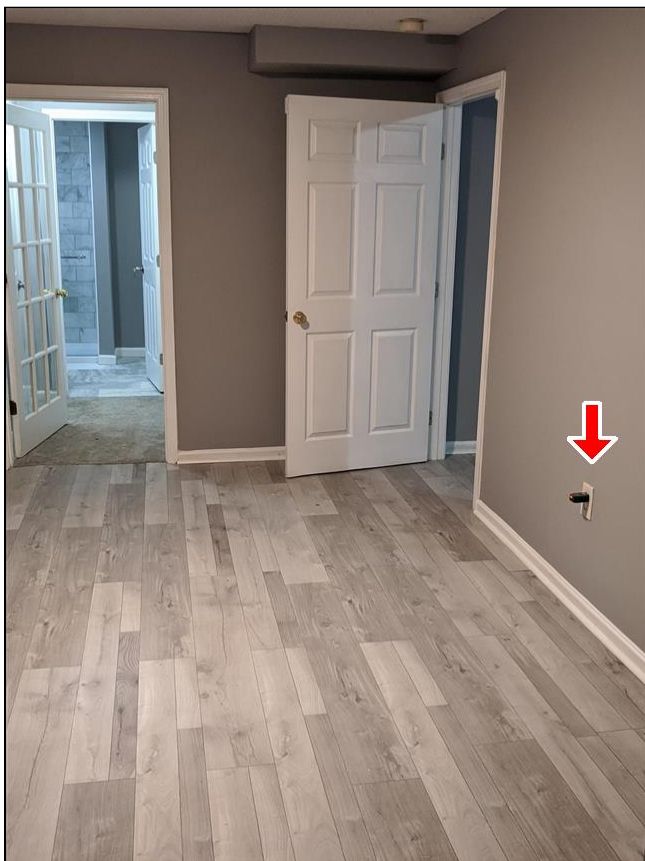
6.3 Item 4(Picture)

(4) Outlet in basement near utility closet has a Hot/Neutral reverse. A qualified electrician should correct as needed.

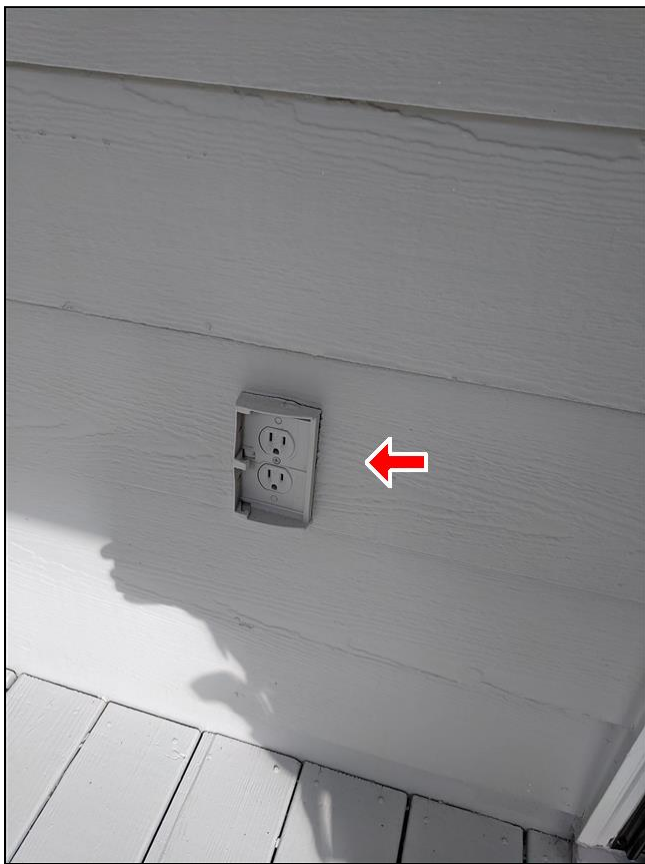
6.4 Item 1(Picture)

**6.4** (1) The outside outlet cover (left of front door) is damaged and needs repair or replace. The outlet is also not GFCI rated. A qualified electrician should replace with a proper GFCI outlet.

(1) The outside outlet cover (left of front door) is damaged and needs repair or replace. The outlet is also not GFCI rated. A qualified electrician should replace with a proper GFCI outlet.

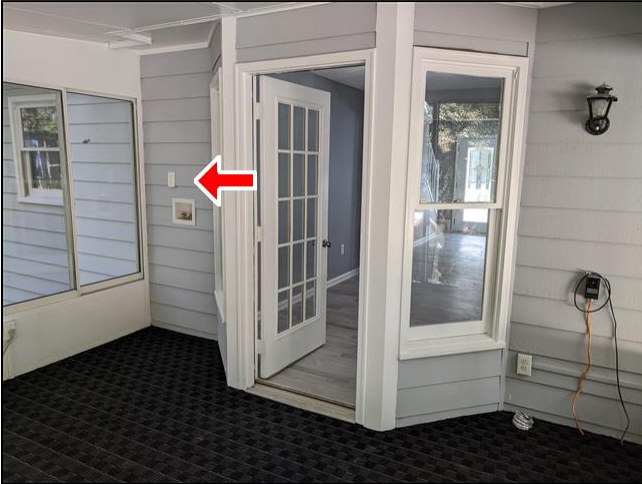
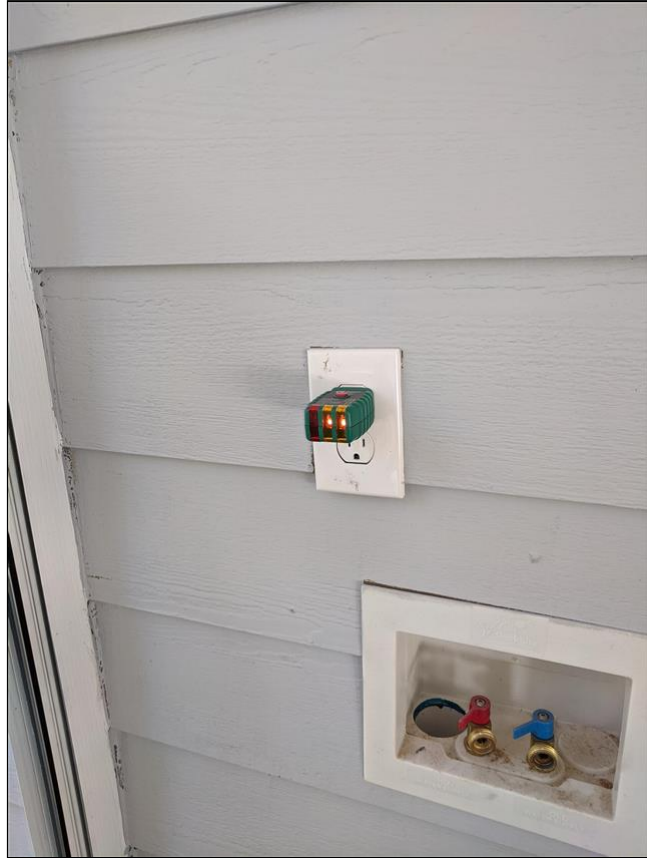
6.4 Item 2(Picture)

(2) The outlet to the left of the Covered Deck is an exterior outlet and not GFCI rated. A qualified electrician should replace with a proper GFCI outlet.

(2) The outlet to the left of the Covered Deck is an exterior outlet and not GFCI rated. A qualified electrician should replace with a proper GFCI outlet.

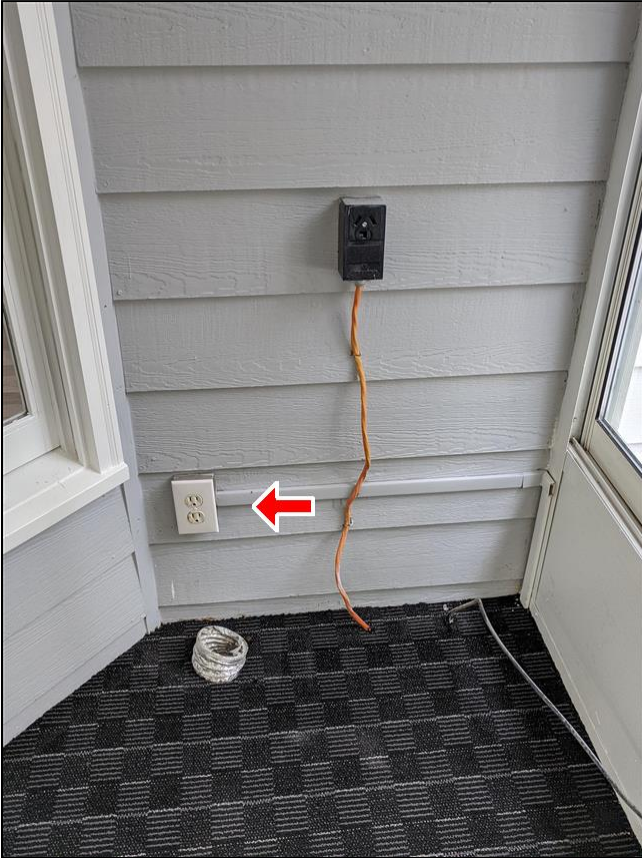
6.4 Item 4(Picture)

(3) Outlet to the right of the Covered Deck is an exterior outlet and not GFCI rated. A qualified electrician should replace with a proper GFCI outlet.

(3) Outlet to the right of the Covered Deck is an exterior outlet and not GFCI rated. A qualified electrician should replace with a proper GFCI outlet.

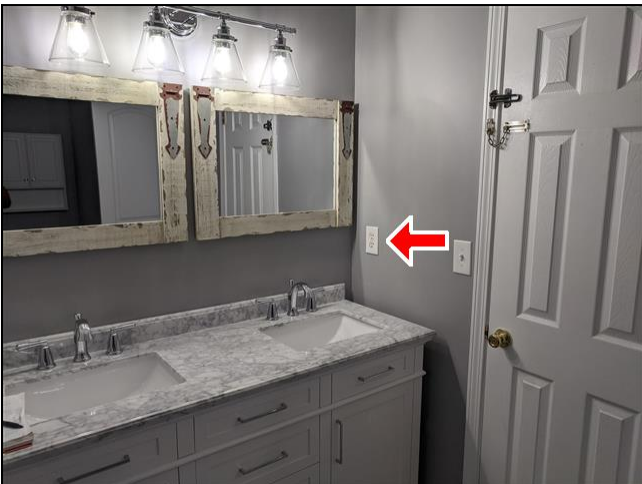
6.4 Item 5(Picture)

(4) The outlet near the Bathroom Sink on Main Level is not GFCI rated. A qualified electrician should replace with a proper GFCI outlet.

(4) The outlet near the Bathroom Sink on Main Level is not GFCI rated. A qualified electrician should replace with a proper GFCI outlet.

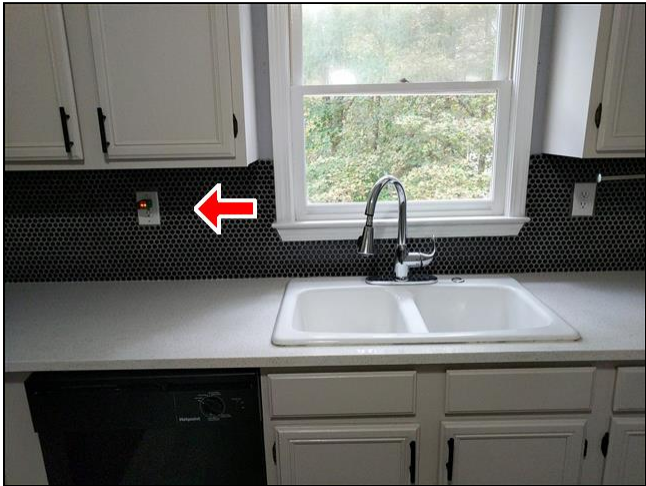
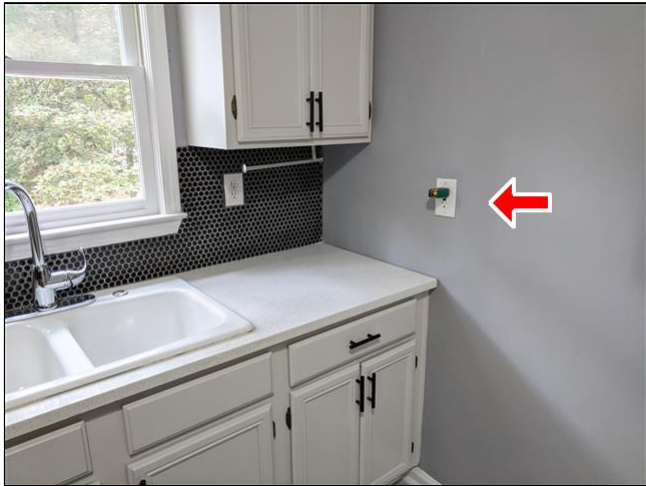
6.5 Item 1(Picture)

6.5 At least Two GFCI (Ground Fault Circuit Interrupter) outlet at at the Kitchen damaged or defective. A qualified licensed electrical contractor should perform repairs that involve wiring and replace the 2 outlets.

At least Two GFCI (Ground Fault Circuit Interrupter) outlet at the Kitchen damaged or defective. A qualified licensed electrical contractor should perform repairs that involve wiring and replace the 2 outlets.

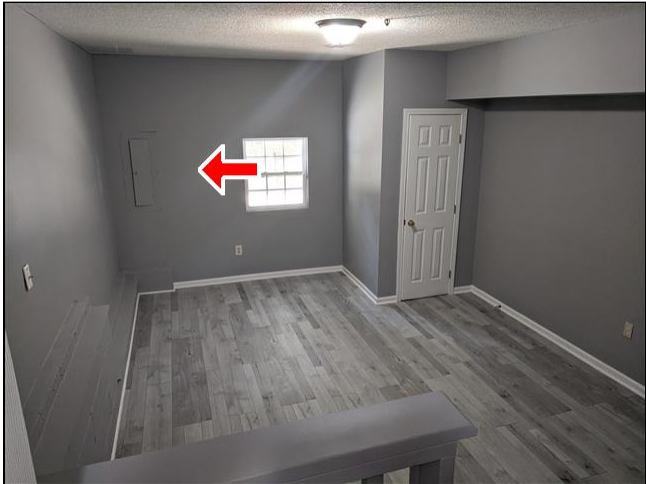
6.6 Item 1(Picture)

6.6 The main panel box is located at the basement.

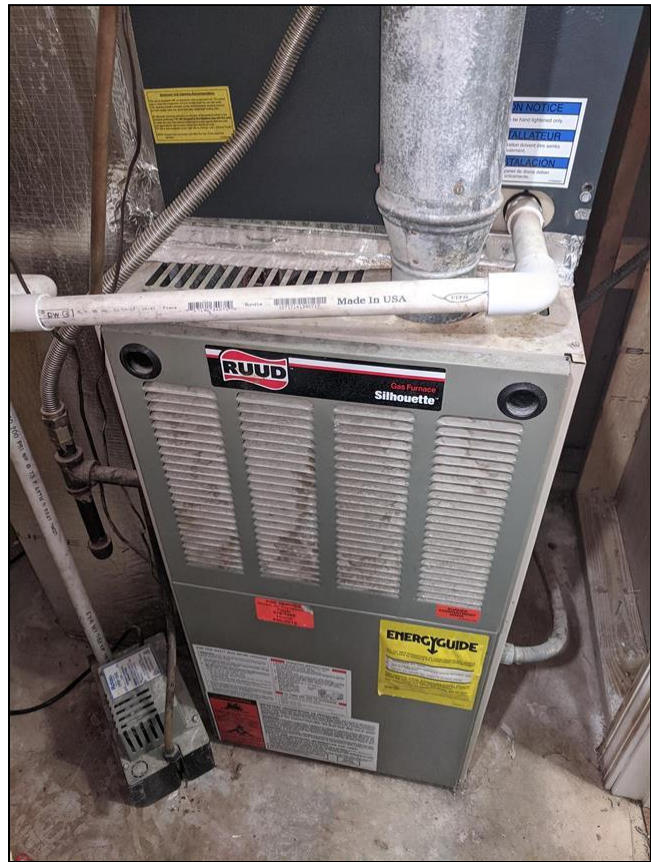
7.0 Item 1(Picture)

7.0 Although I was unable to determine the age of the RUUD furnace, it appeared to be an older unit. The unit did perform well during the inspection.

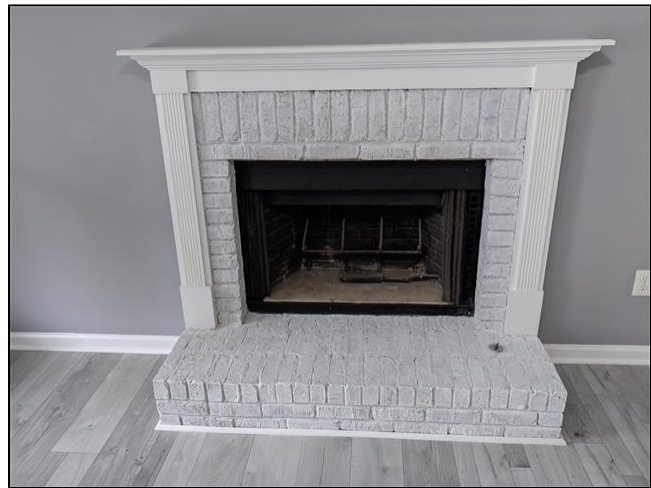
7.5 Item 1(Picture)

7.5 The liner was mainly visible and appears good except for creosote dust that may conceal a hairline crack until cleaned and inspected by a licensed chimney sweep. For a detailed inspection of liner, I recommend a qualified chimney sweep inspect for safety.

The liner was mainly visible and appears good except for creosote dust that may conceal a hairline crack until cleaned and inspected by a licensed chimney sweep. For a detailed inspection of liner, I recommend a qualified chimney sweep inspect for safety.

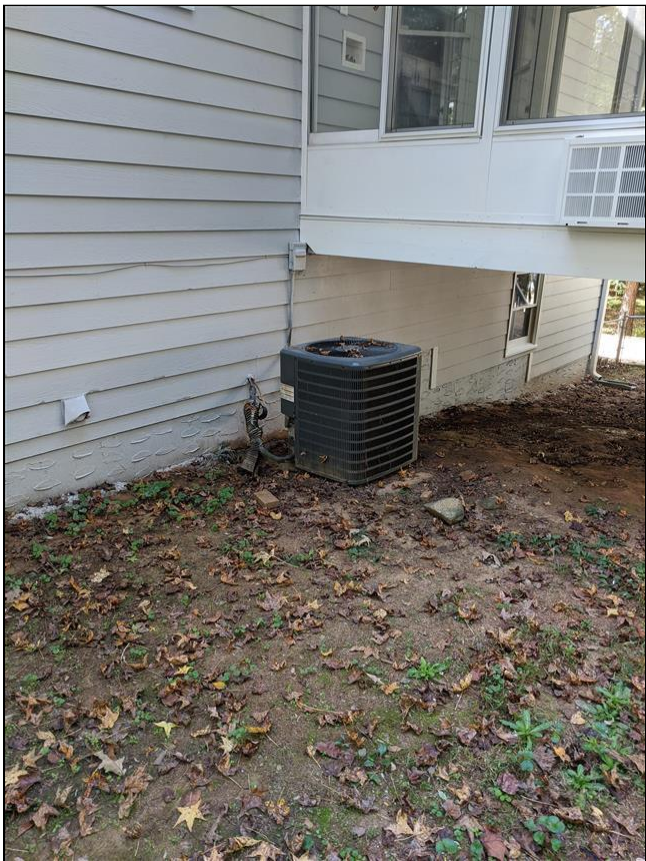
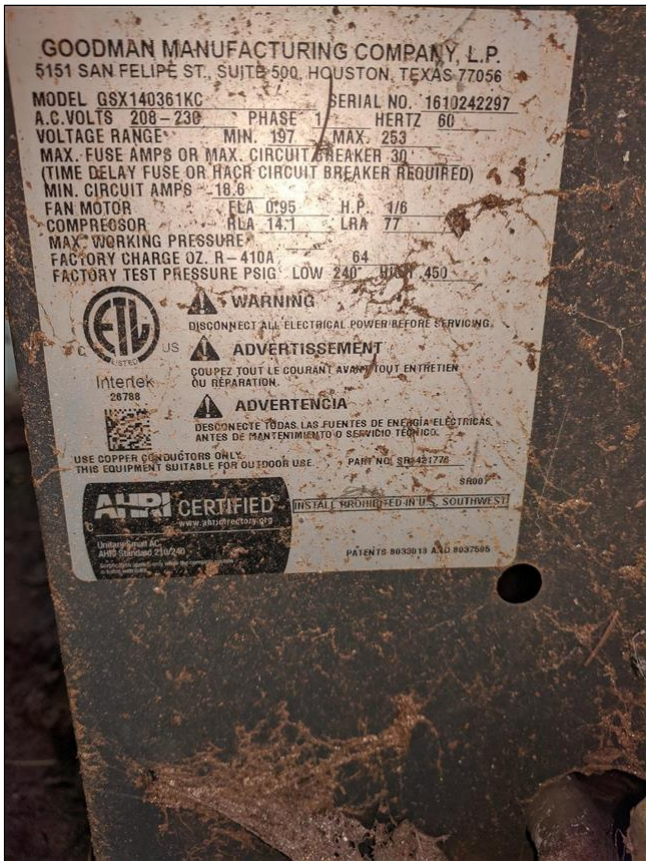
7.8 Item 1(Picture)

7.8 (1) The Goodman AC unit has a manufacturing date of: October 2016

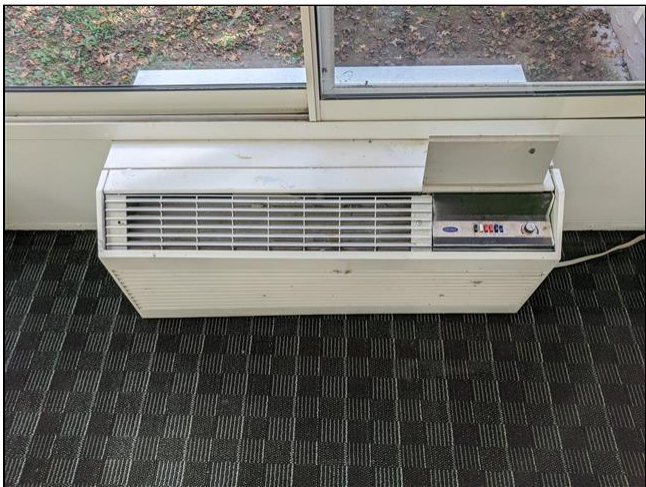
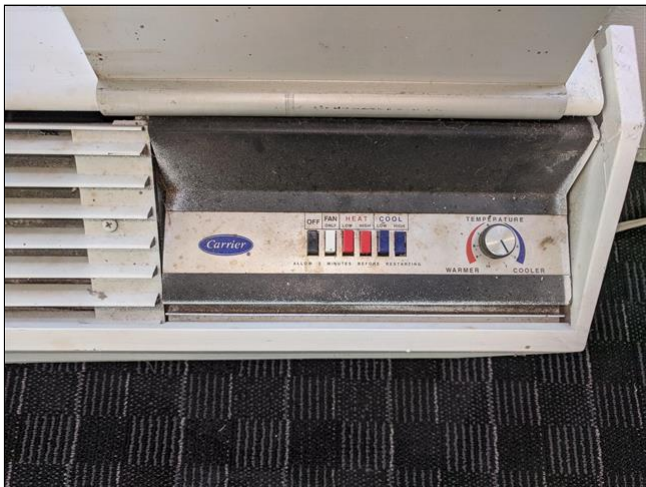
7.8 Item 3(Picture)

(2) The AC/Heat Floor Unit at covered deck did function properly for heat but did not reach proper temperatures for cooling. Repair or replace by a qualified HVAC professional.

(2) The AC/Heat Floor Unit at covered deck did function properly for heat but did not reach proper temperatures for cooling. Repair or replace by a qualified HVAC professional.

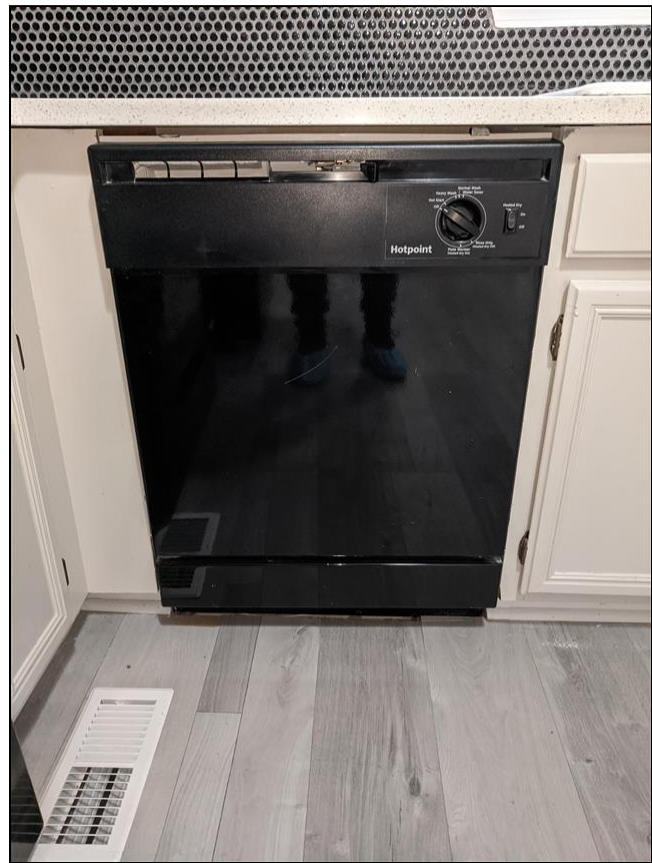
9.0 Item 1(Picture)

9.0 The dishwasher is loose and needs securing to underside of countertop (using a proper length screw). I recommend repair as necessary.

The dishwasher is loose and needs securing to underside of countertop (using a proper length screw). I recommend repair as necessary.

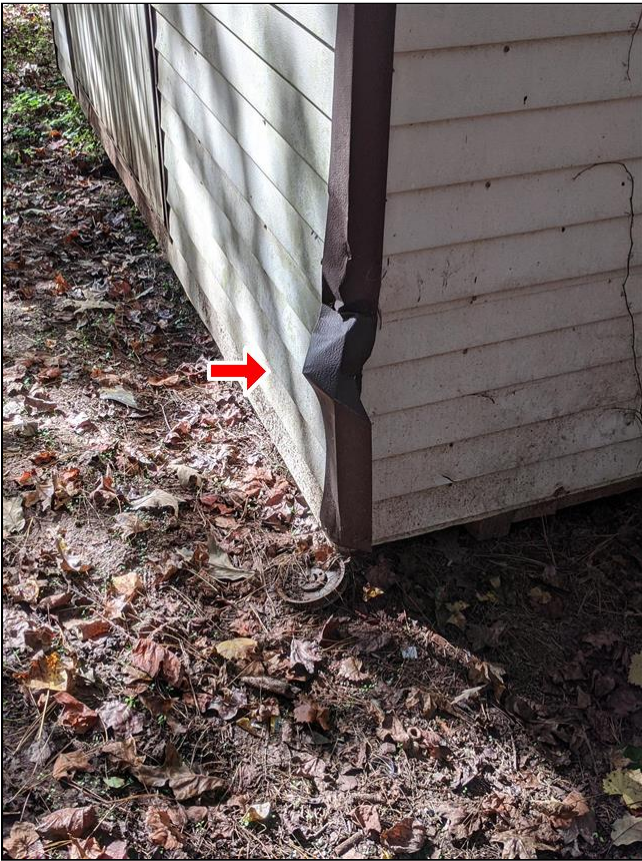
10.1 Item 1(Picture)

**10.1** Right edge of shed has bent trim, Repair/replace to prevent further rust and deterioration.

Right edge of shed has bent trim, Repair/replace to prevent further rust and deterioration.

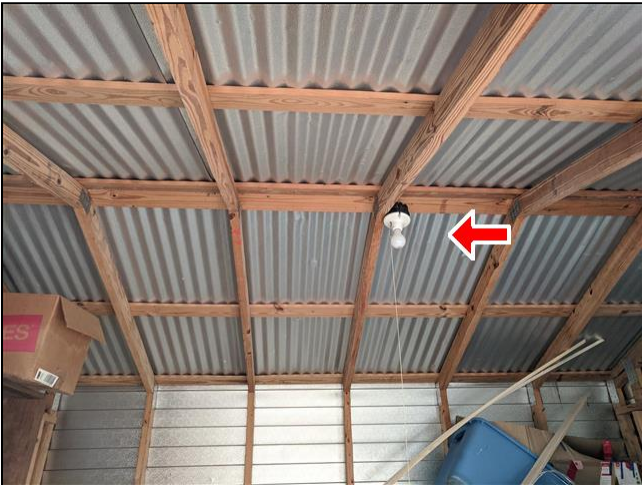
10.5 Item 1(Picture)

**10.5** The light fixture in shed did not work during the time of inspection. A bulb replacement is likely needed..

The light fixture in shed did not work during the time of inspection. A bulb replacement is likely needed..
