Inspection Report

Sample Report

555 Jane Doe Dr,
Atlanta GA 30331

Precise Inspection Group

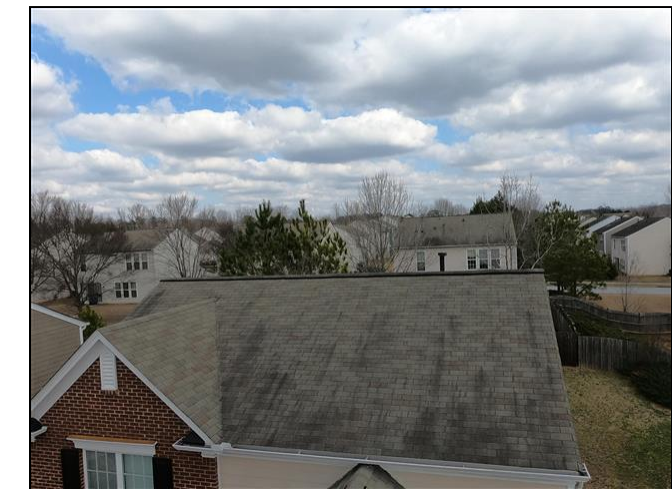
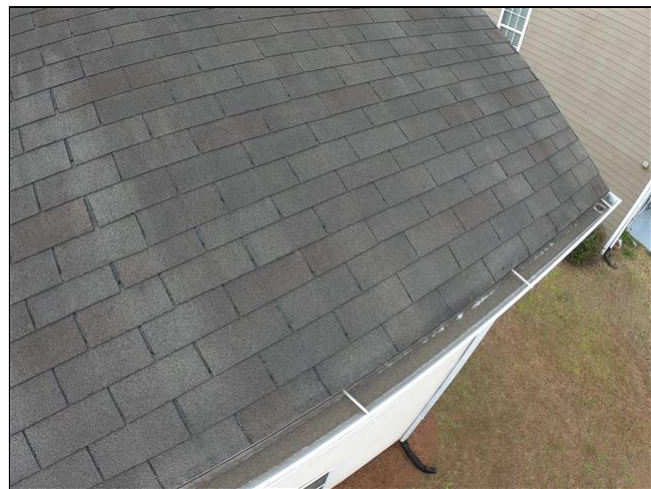
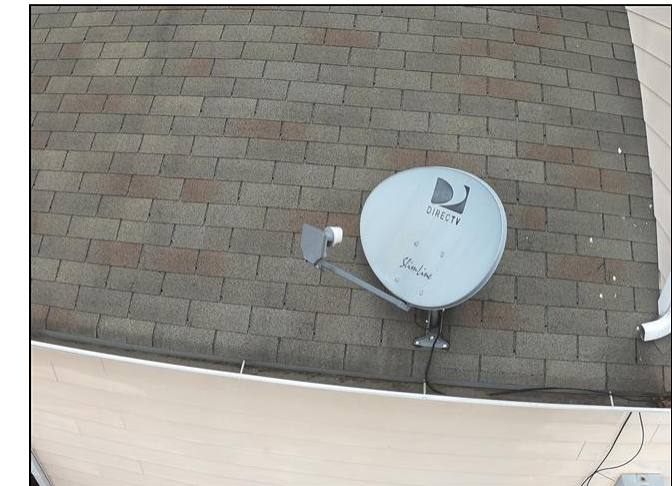
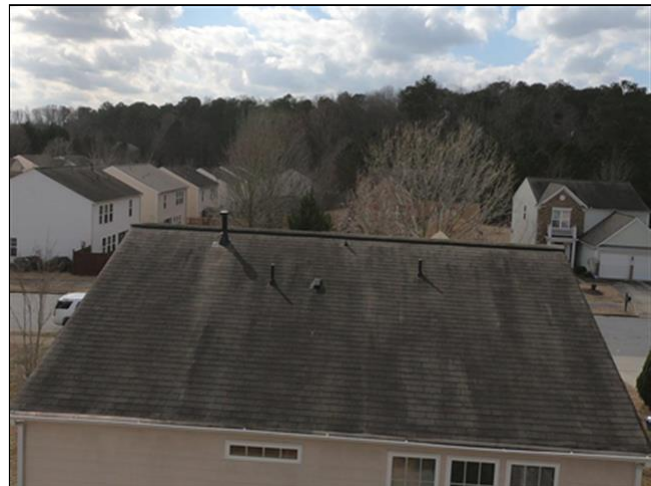
1.0 Item 1(Picture)

1.0 Although the roof showed no signs of previous repairs. The Roof shingles are nearing the end of its life cycle. Roof coverings will need replacing before 5 years. I recommend repair as desired.

Although the roof showed no signs of previous repairs. The Roof shingles are nearing the end of its life cycle. Roof coverings will need replacing before 5 years. I recommend repair as desired.

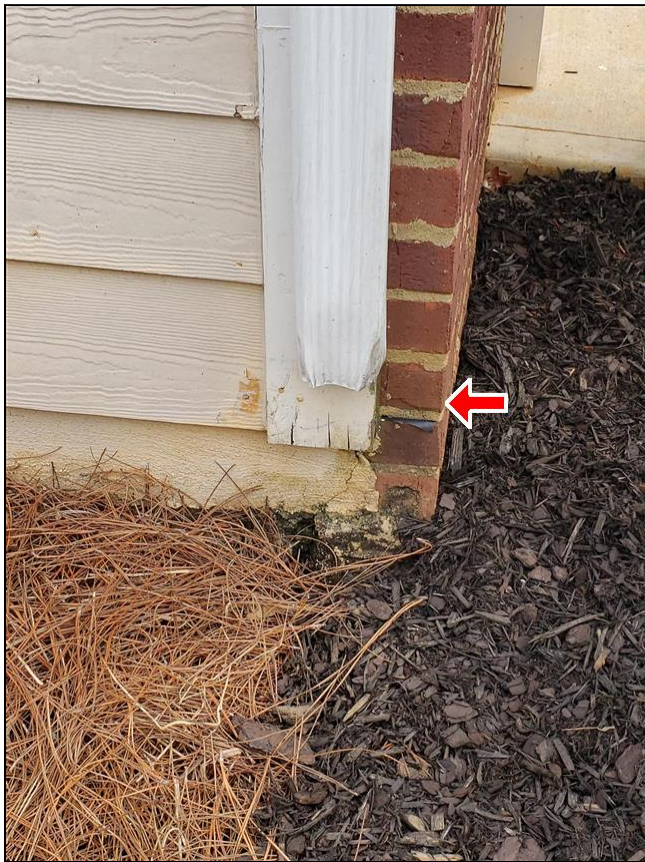
1.3 Item 1(Picture)

1.3 The downspout missing elbow extension at the front (left of main entry). A qualified person should repair or replace as needed to encourage water to flow away from the home.

The downspout missing elbow extension at the front (left of main entry). A qualified person should repair or replace as needed to encourage water to flow away from the home.

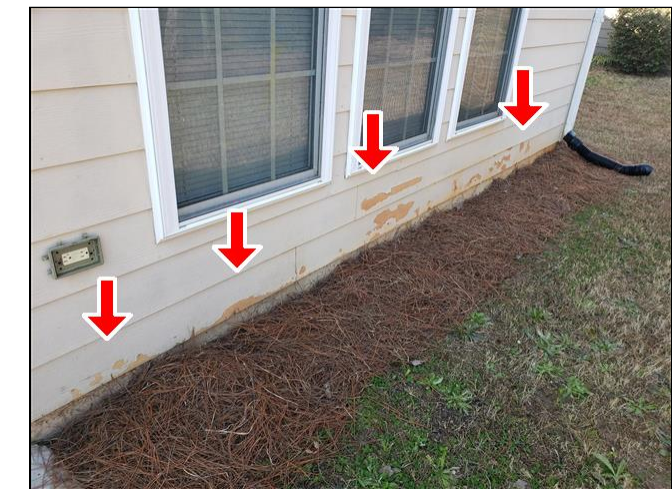
2.0 Item 1(Picture)

2.0 The Composite board siding at the exterior in areas rear of home peeling paint or failing. Deterioration can eventually occur if not corrected. I recommend prep and paint using a qualified contractor.

The Composite board siding at the exterior in areas rear of home peeling paint or failing. Deterioration can eventually occur if not corrected. I recommend prep and paint using a qualified contractor.

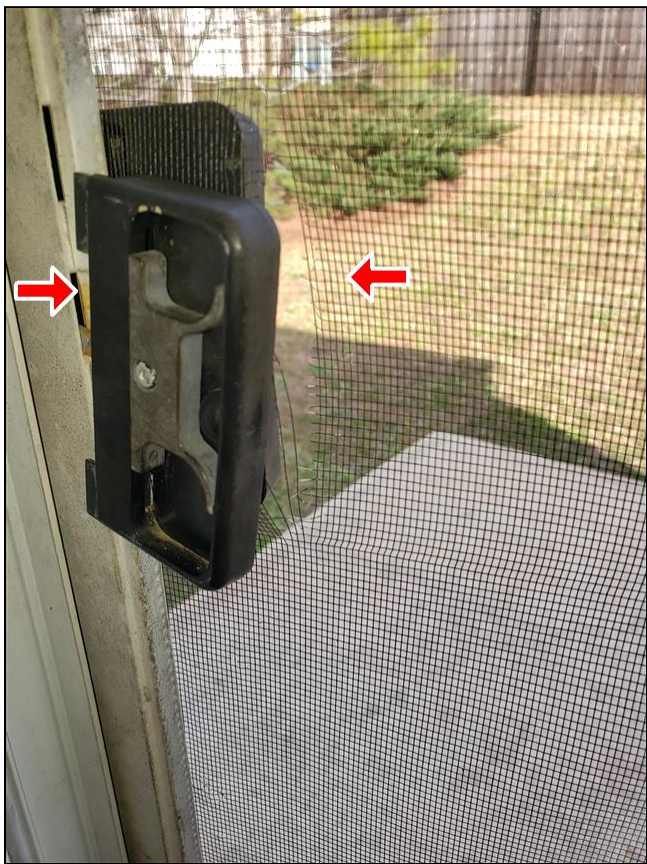
2.1 Item 1(Picture)

2.1 The screen door at the rear of home (patio) has a damaged screen and broken at latch. This is a maintenance issue and is for your information. Replace as desired.

The screen door at the rear of home (patio) has a damaged screen and broken at latch. This is a maintenance issue and is for your information. Replace as desired.

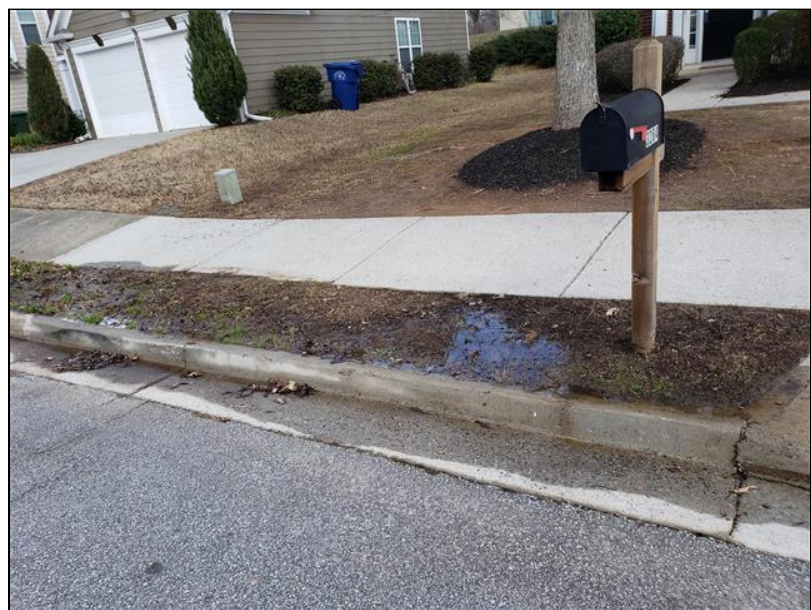
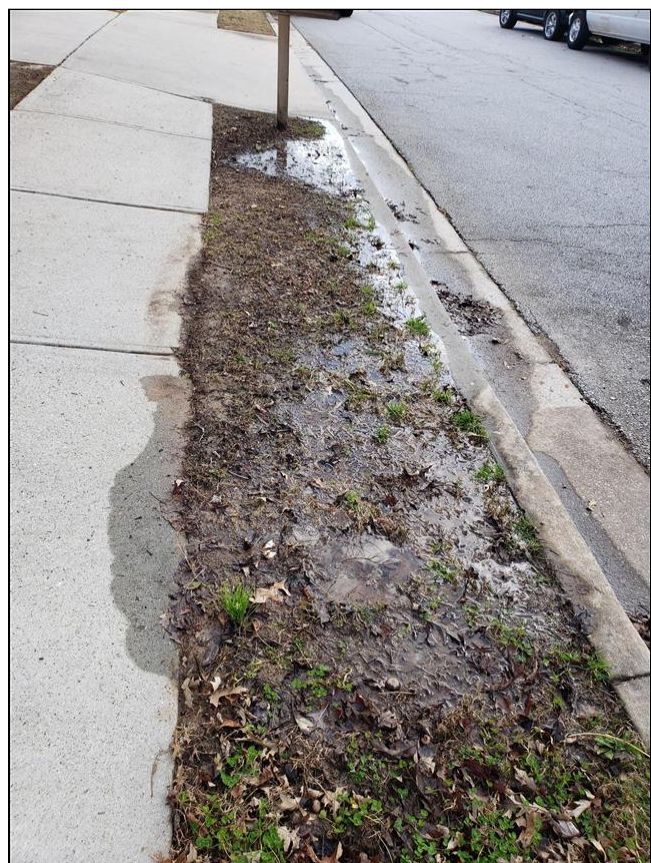
2.6 Item 1(Picture)

2.6 Standing water was observed at the front of home near the mailbox. The area appeared to not have drainage. A licensed contractor should inspect and install a proper drainage system to encourage water to flow properly to prevent erosion and further deterioration.

Standing water was observed at the front of home near the mailbox. The area appeared to not have drainage. A licensed contractor should inspect and install a proper drainage system to encourage water to flow properly to prevent erosion and further deterioration.

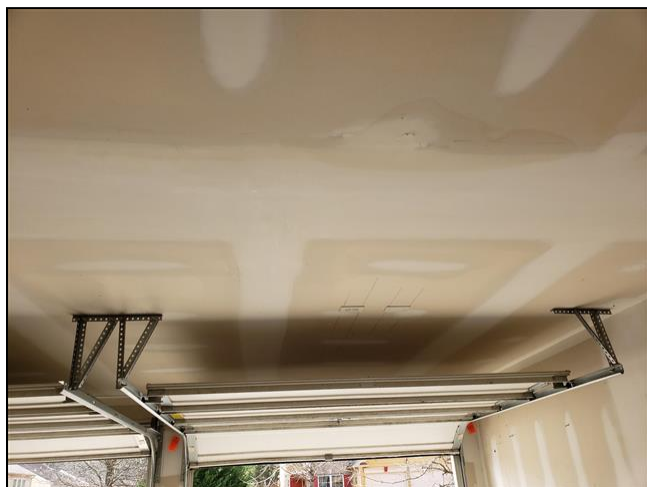
3.0 Garage ceiling is unfinished. While this damage is cosmetic, the repair cost should be considered due to the amount of work required. I recommend prep and paint using a qualified contractor.

Garage ceiling is unfinished. While this damage is cosmetic, the repair cost should be considered due to the amount of work required. I recommend prep and paint using a qualified contractor.

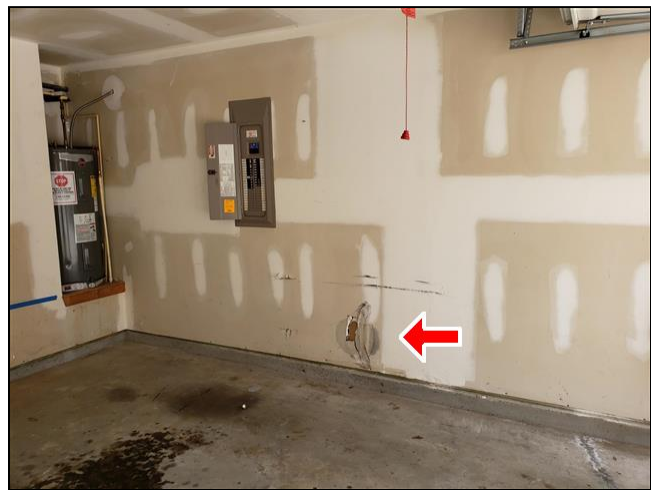
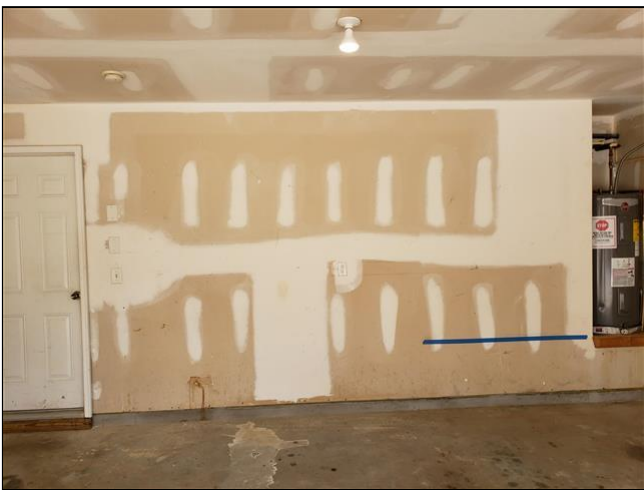
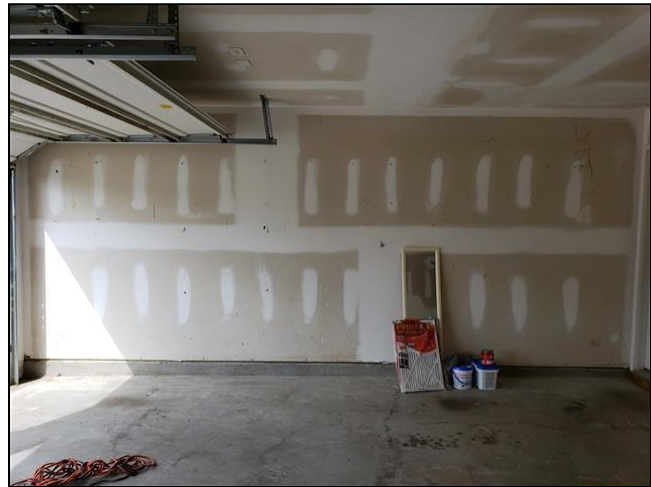
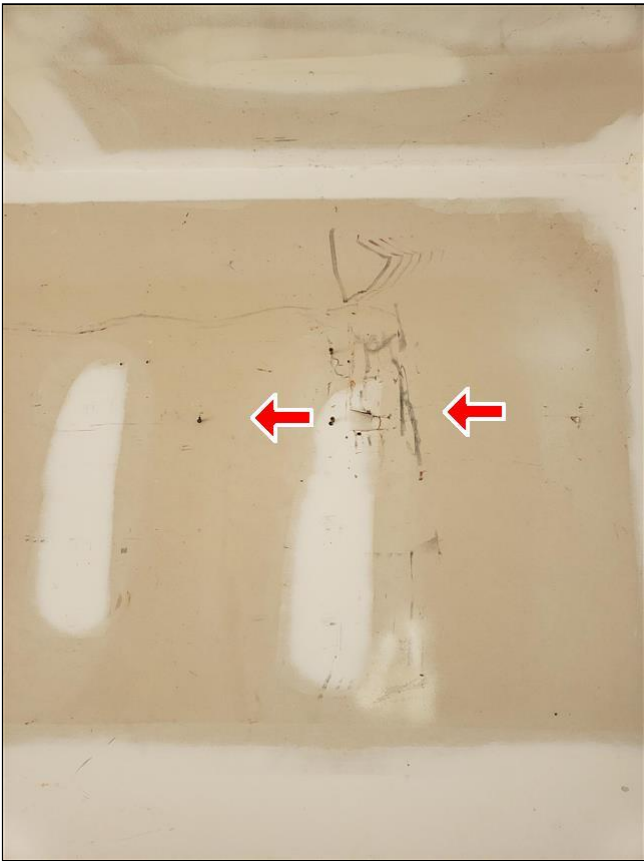
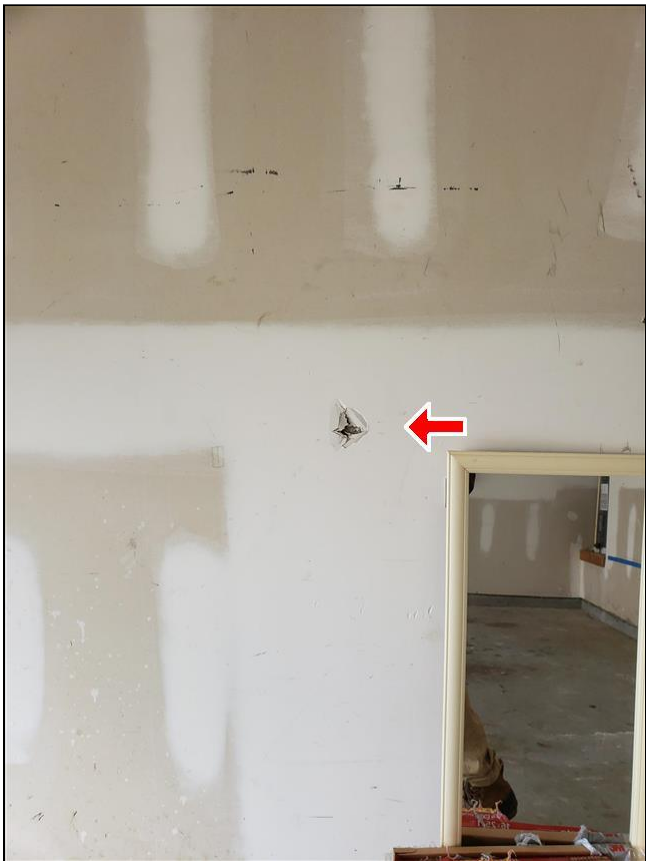
3.1 Item 1(Picture)

3.1 Garage drywall is unfinished and damaged in several areas. While this damage is cosmetic, the repair cost should be considered due to the amount of work required. I recommend prep and paint using a qualified contractor.

Garage drywall is unfinished and damaged in several areas. While this damage is cosmetic, the repair cost should be considered due to the amount of work required. I recommend prep and paint using a qualified contractor.

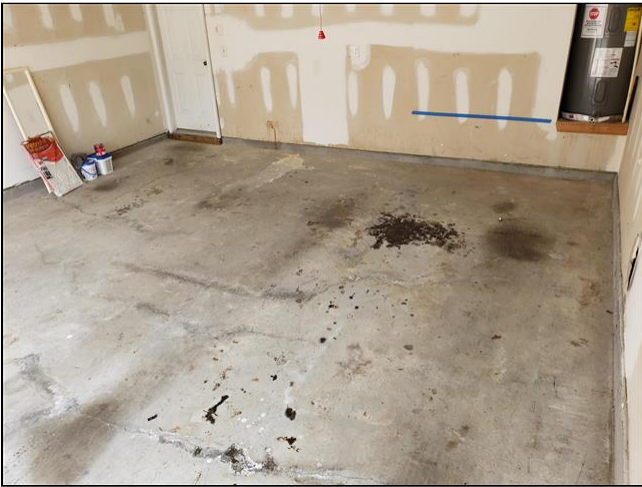
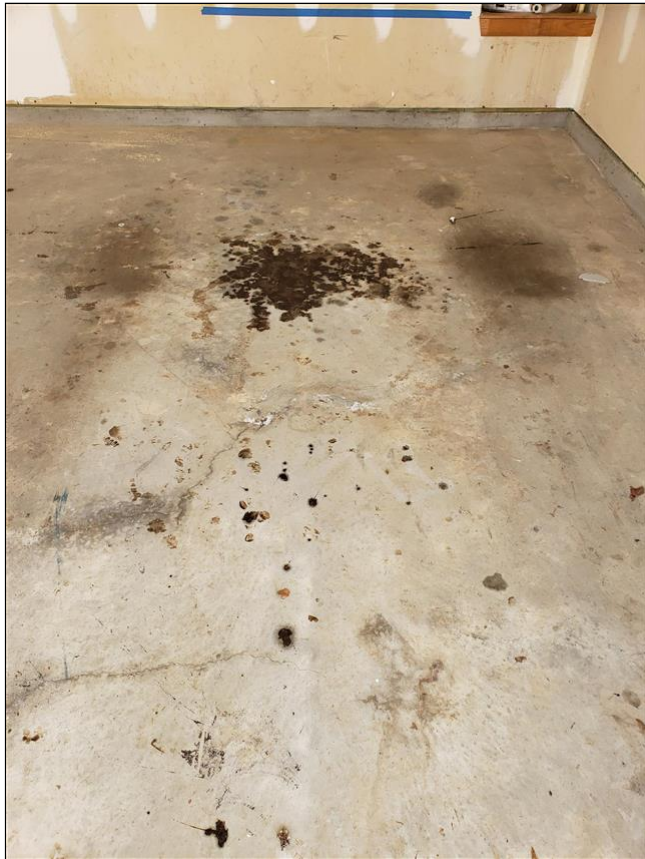
3.2 Item 1(Picture)

3.2 Garage floor stained in several areas. I recommend pressure-washing by a qualified contractor.

Garage floor stained in several areas. I recommend pressure-washing by a qualified contractor.

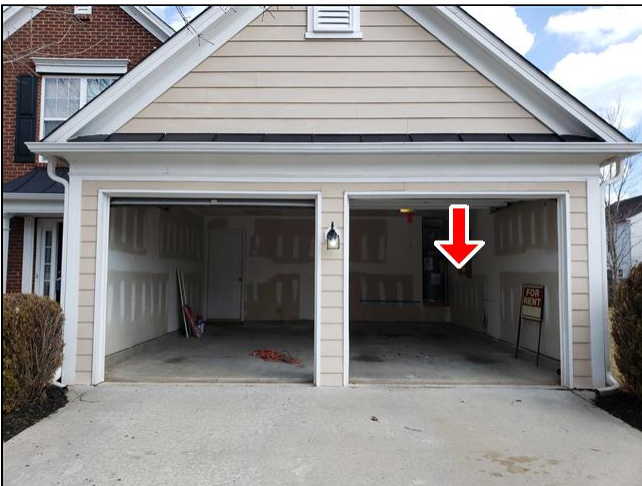
3.3 Item 1(Picture)

3.3 Right Garage Door automatic. Left Garage Door manual. This is for your information.

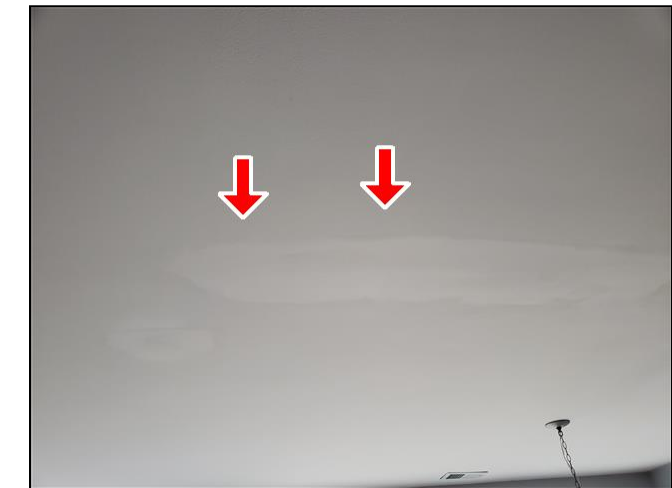
4.0 Item 1(Picture)

4.0 Kitchen ceiling showed areas of previous repairs/patching near sink. No active moisture was detected during the inspection. Repairs seem to be adequate. This is for your information.

Kitchen ceiling showed areas of previous repairs/patching near sink. No active moisture was detected during the inspection. Repairs seem to be adequate. This is for your information.

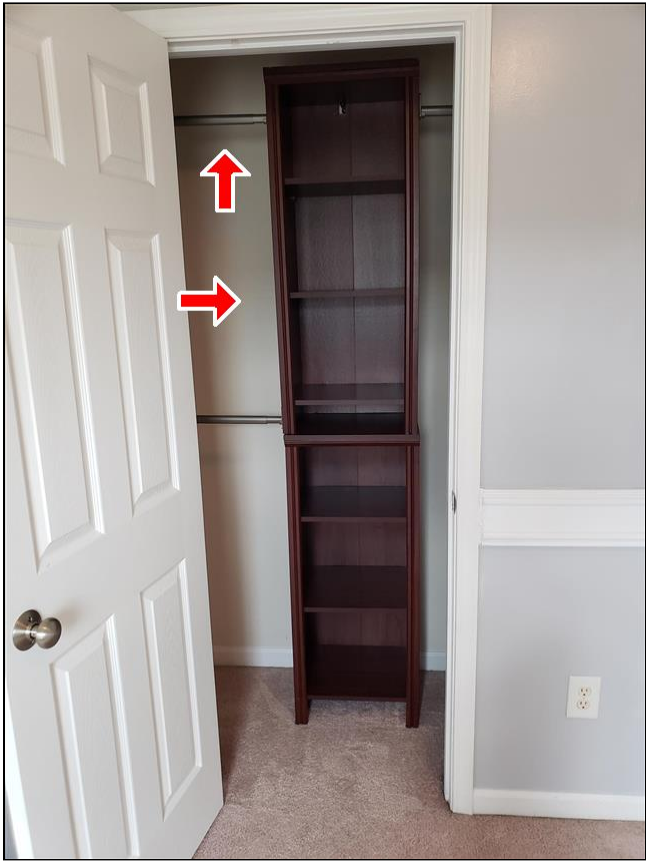
4.1 Item 1(Picture)

4.1 Closet rod and shelf in 2nd Guest Bedroom was not secure during the inspection. A replacement is likely needed. I recommend replacing by a qualified contractor.

Closet rod and shelf in 2nd Guest Bedroom was not secure during the inspection. A replacement is likely needed. I recommend replacing by a qualified contractor.

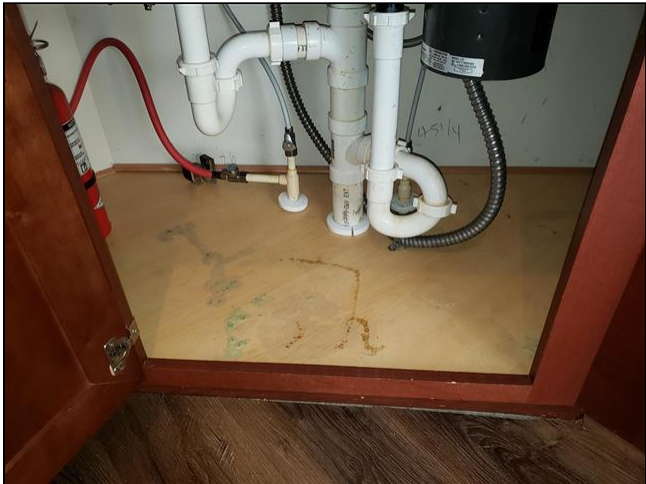
4.4 Item 1(Picture)

4.4 Water stains from a previous leak was observed under Kitchen sink. No active leaks or moisture was detected. I recommend monitoring frequently as a part standard maintenance.

Water stains from a previous leak was observed under Kitchen sink. No active leaks or moisture was detected. I recommend monitoring frequently as a part standard maintenance.

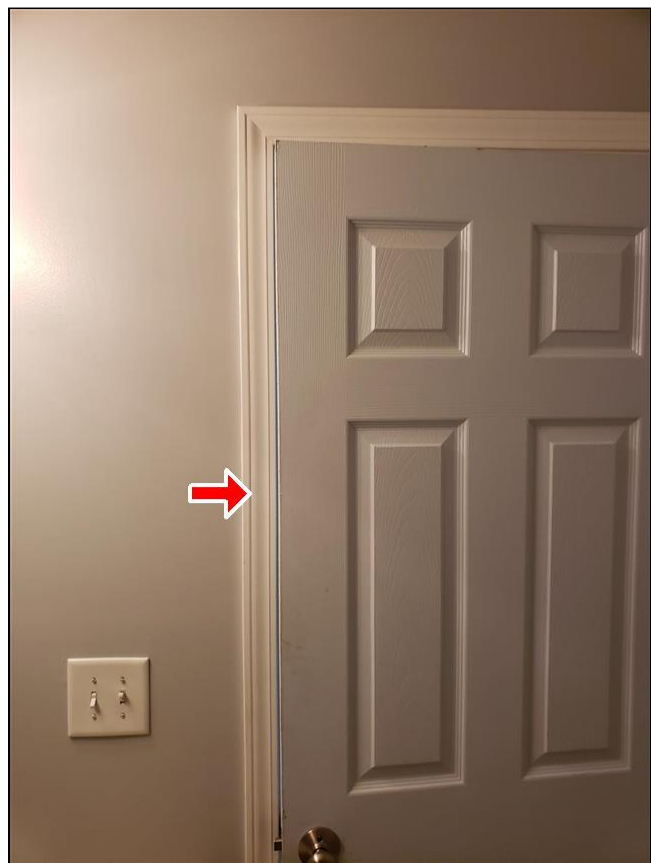
4.5 Item 1(Picture)

4.5 The Door does not fit opening properly nor shuts (out of square) at the Guest Bathroom on top floor. A qualified contractor should inspect and repair/replace as needed. Please follow through to ensure proper repair or replacement is made.

The Door does not fit opening properly nor shuts (out of square) at the Guest Bathroom on top floor. A qualified contractor should inspect and repair/replace as needed. Please follow through to ensure proper repair or replacement is made.

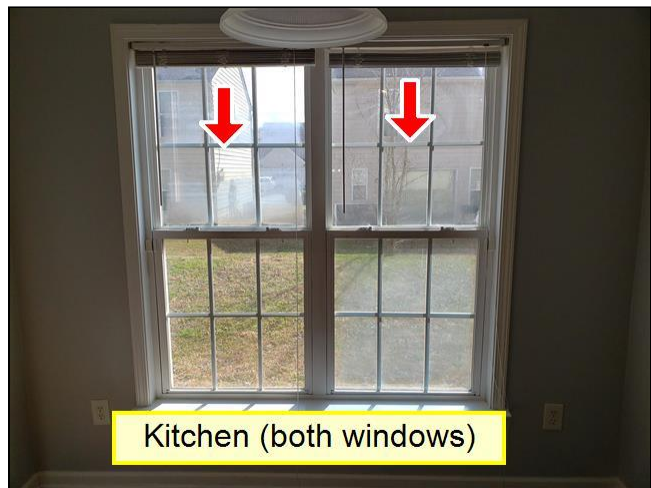
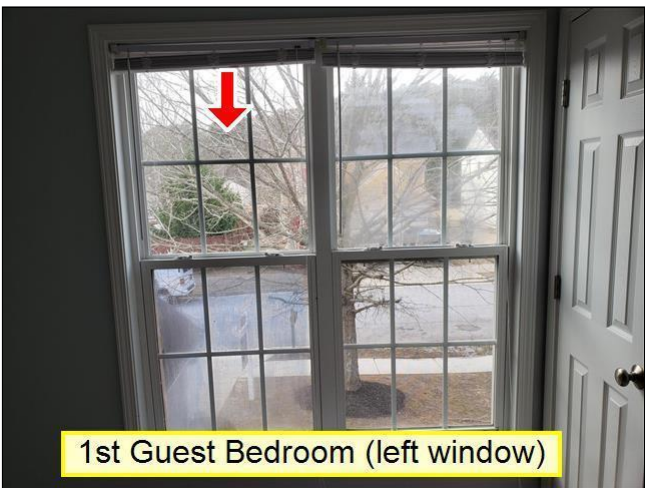
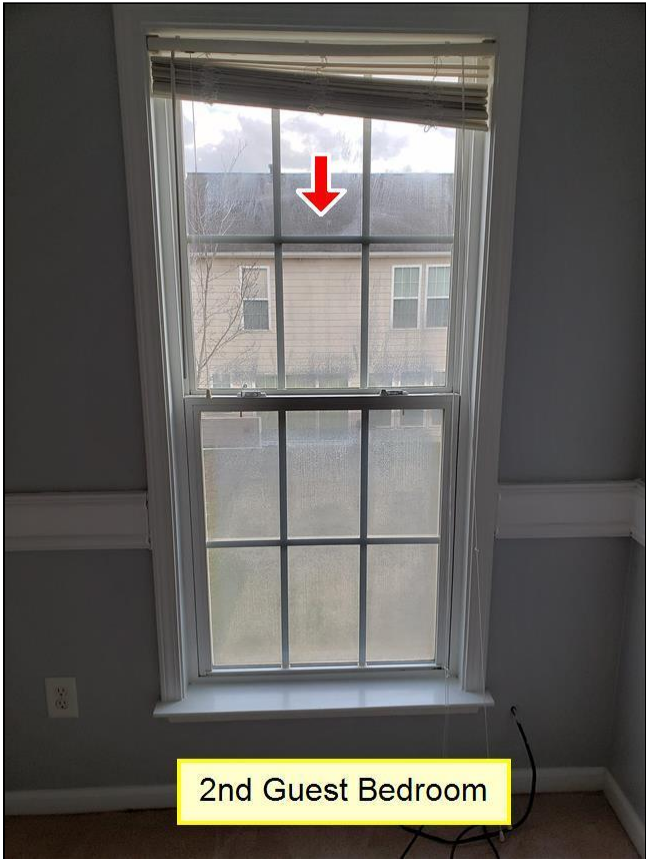
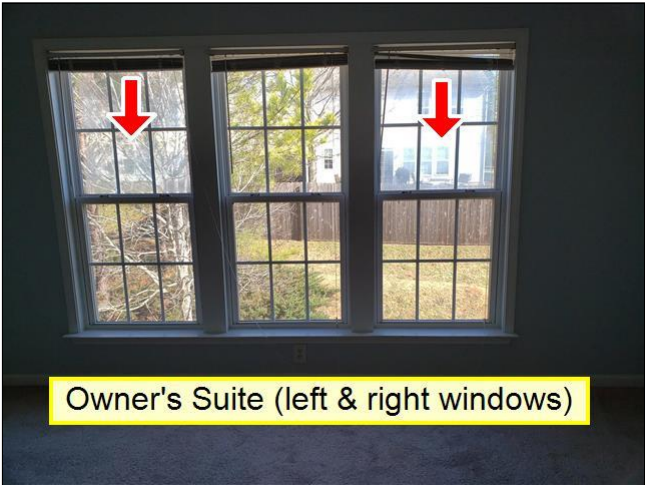
4.6 Item 1(Picture)

4.6 Six windows cloudy (lost seal) throughout the home. In order to correct the cloudy appearance of glass, a replacement of glass pane or the unit will be necessary.

Six windows cloudy (lost seal) throughout the home. In order to correct the cloudy appearance of glass, a replacement of glass pane or the unit will be necessary.

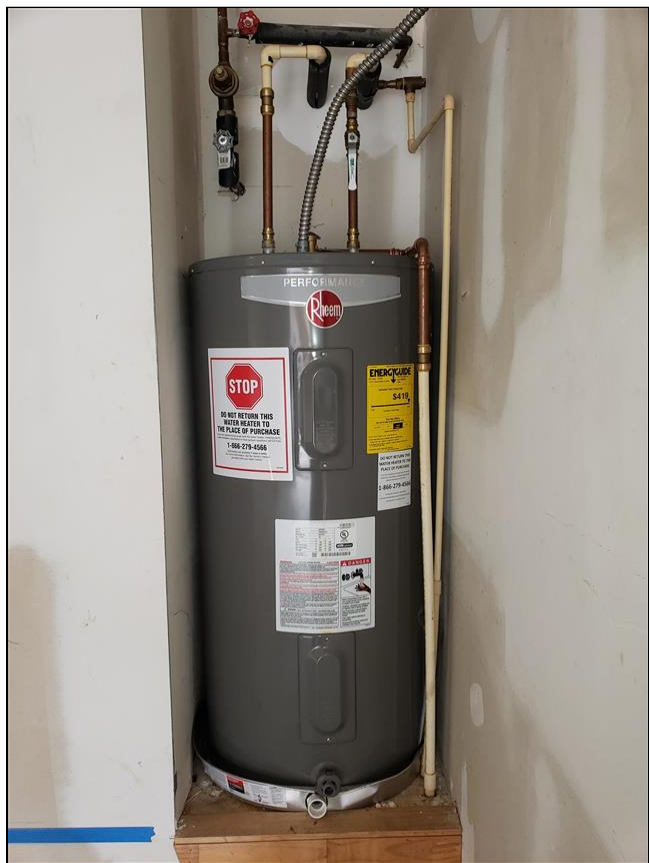
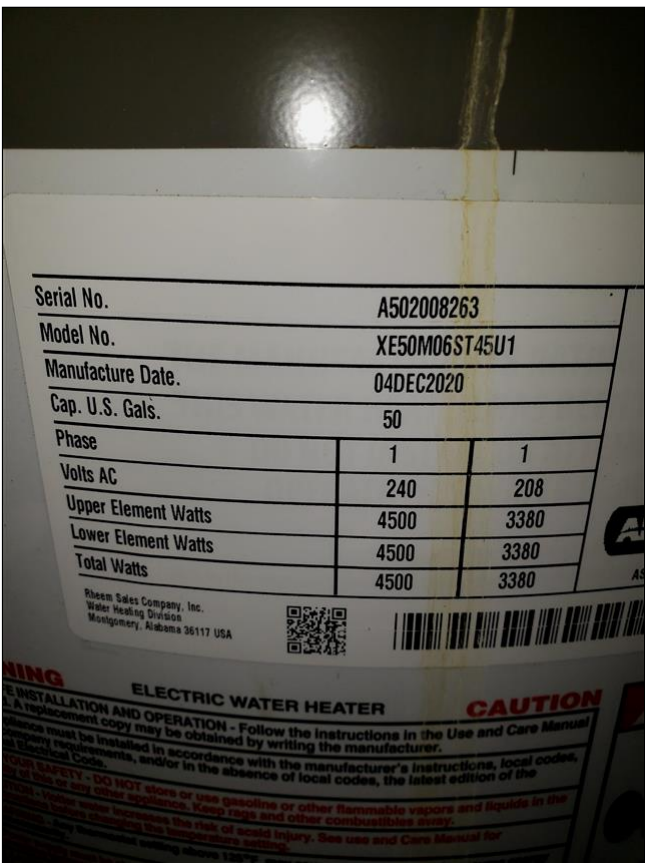
6.2 Item 1(Picture)

6.2 RHEEM water heater has a manufacturing date of: December 2020

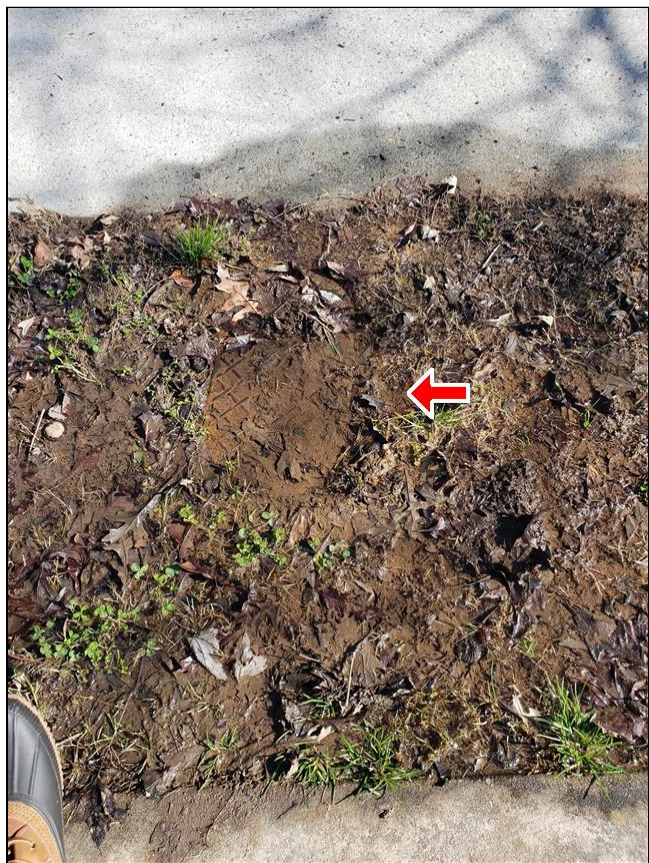
6.3 Item 1(Picture)

6.3 The main shut off is located outside in the ground.

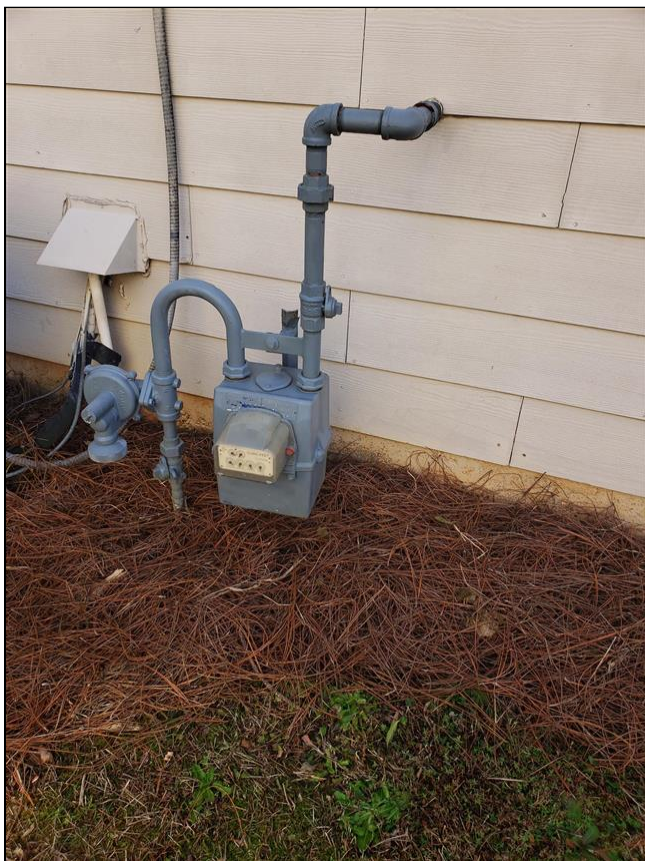
**6.5** Item 1(Picture)

6.5 The main fuel shut off is at gas meter outside

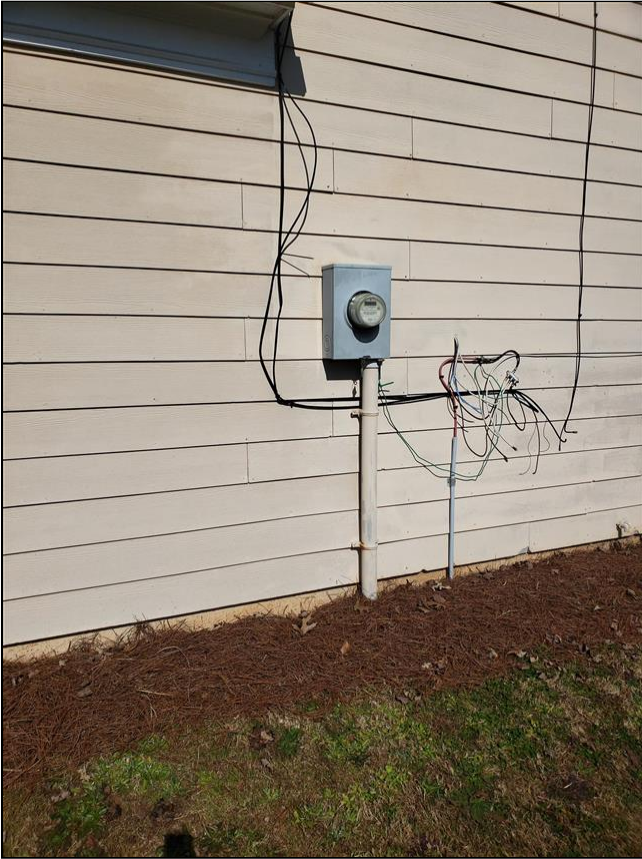
7.0 Item 1(Picture)

7.0 Home has below ground power lines

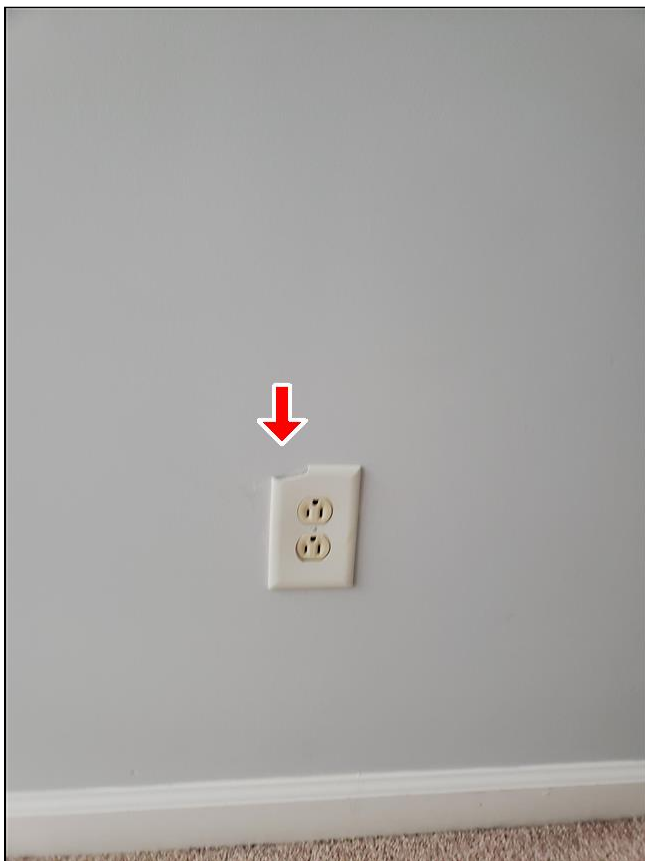
7.3 Item 1(Picture)

7.3 Outlet cover cracked in 1st Guest Bedroom. This is a maintenance issue for your information.

Outlet cover cracked in 1st Guest Bedroom. This is a maintenance issue for your information.

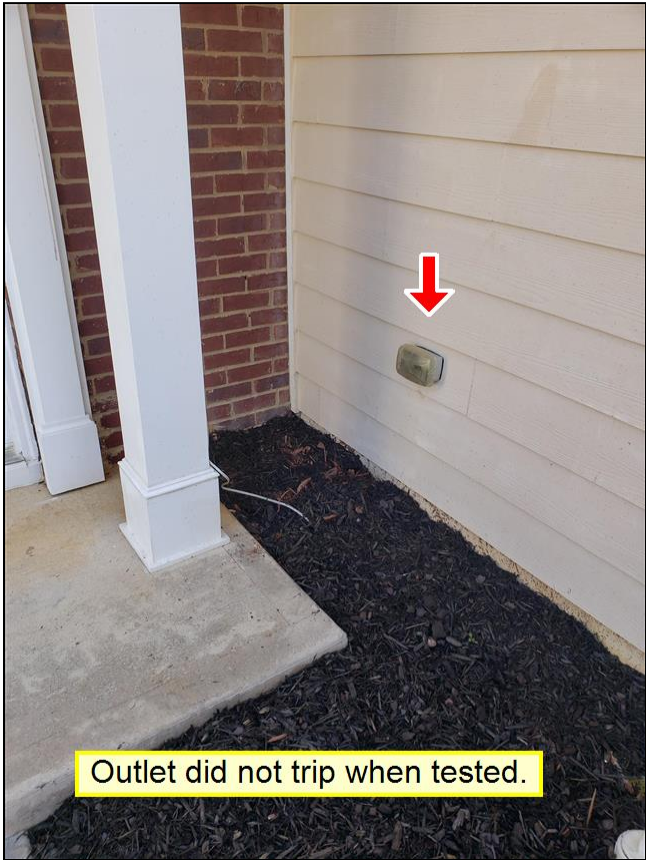
7.5 Item 1(Picture)

7.5 All exterior outlets should be inspected and replaced by a certified electrician. Electrical issues are considered hazardous until repaired.

Outlet did not trip when tested.

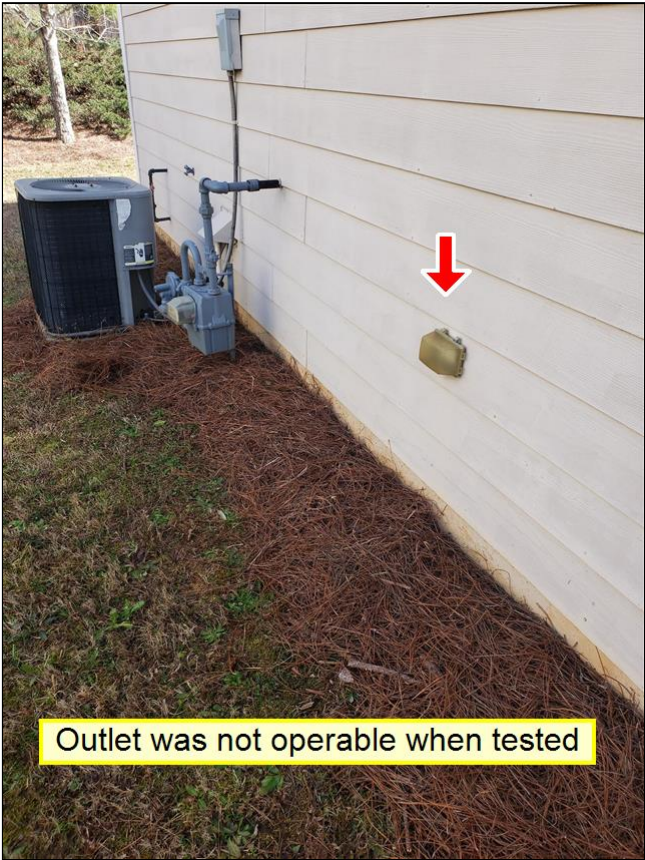
7.5 Item 2(Picture)

Outlet was not operable when tested

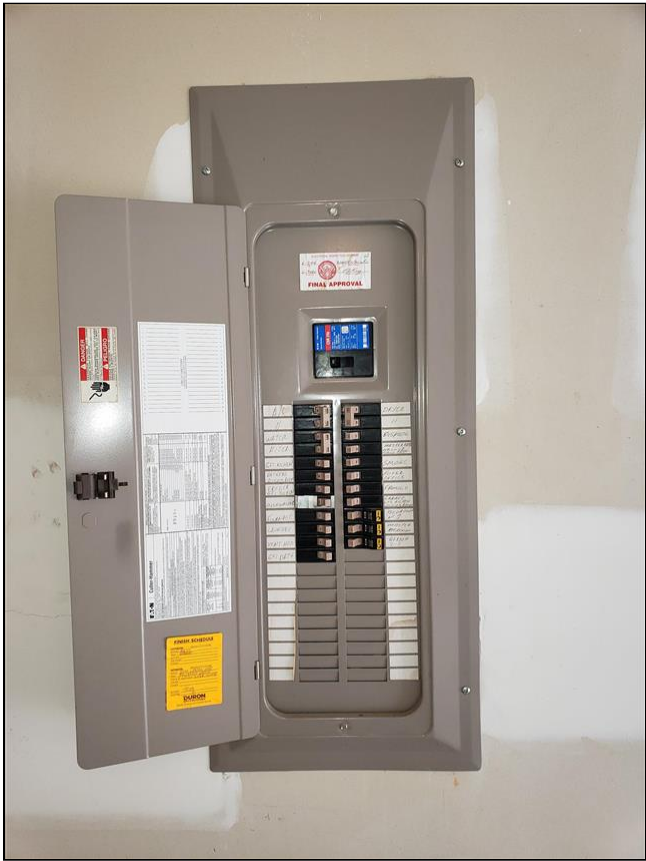
7.6 Item 1(Picture)

7.6 The main panel box is located at the garage.

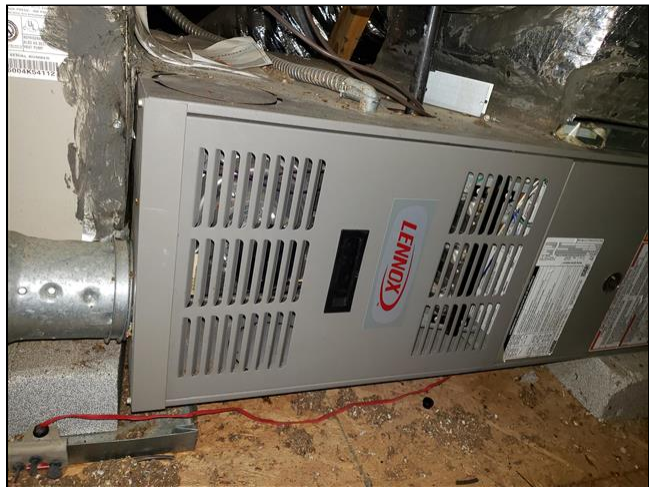
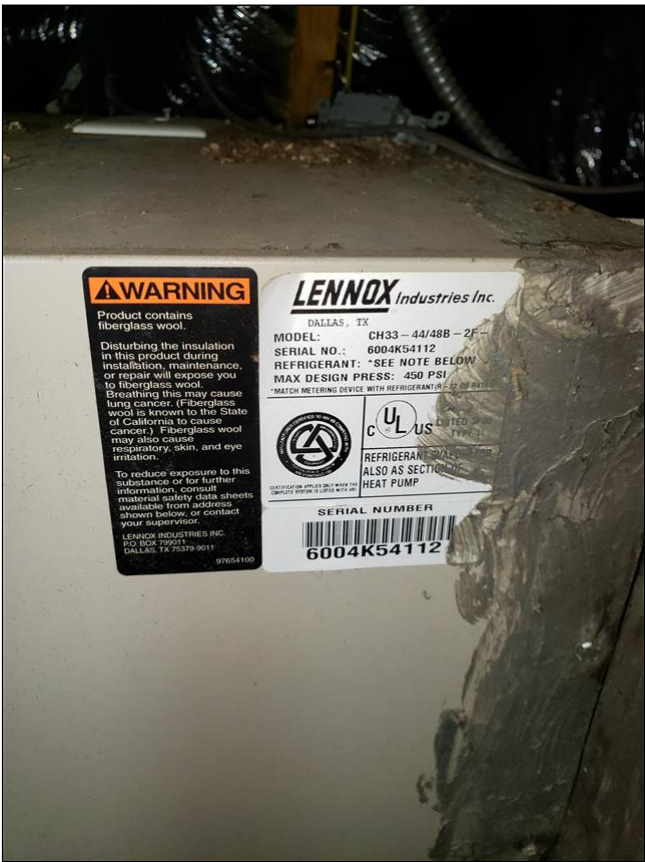
8.0 Item 1(Picture)

8.0 LENNOX Furnace/Air Handler has a manufacturing date of: October 2004. Although the unit is an older unit it did perform well during the inspection. I have seen units fail shortly after a home inspection during the seasonal change from hot to cool weather. I cannot determine how long your Furnace will last before a replacement is necessary.

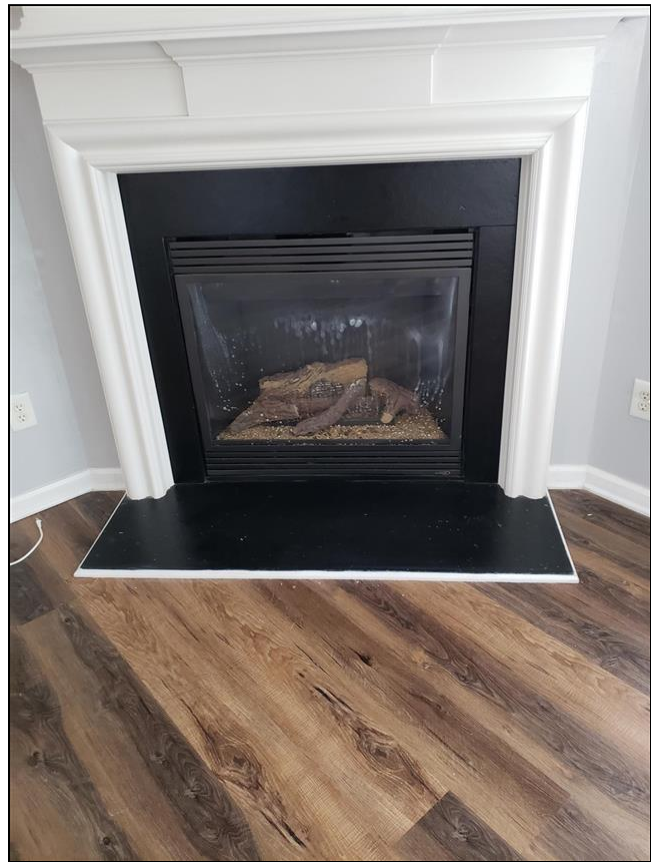
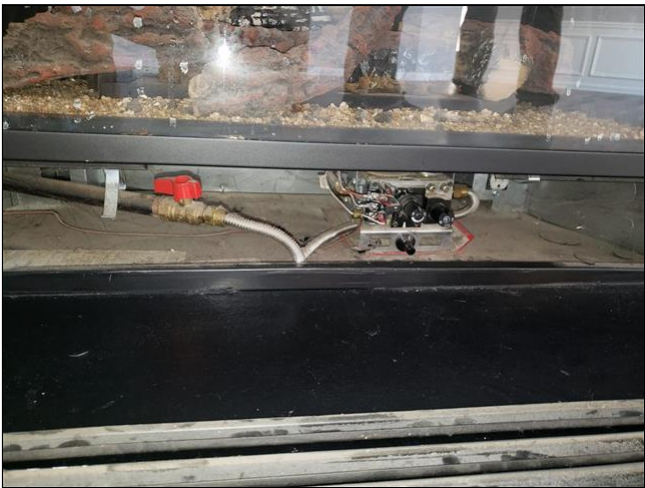
8.6 Item 1(Picture)

8.6 The Fireplace did not ignite during the inspection. I recommend a qualified professional inspect and make necessary repairs.

The Fireplace did not ignite during the inspection. I recommend a qualified professional inspect and make necessary repairs.

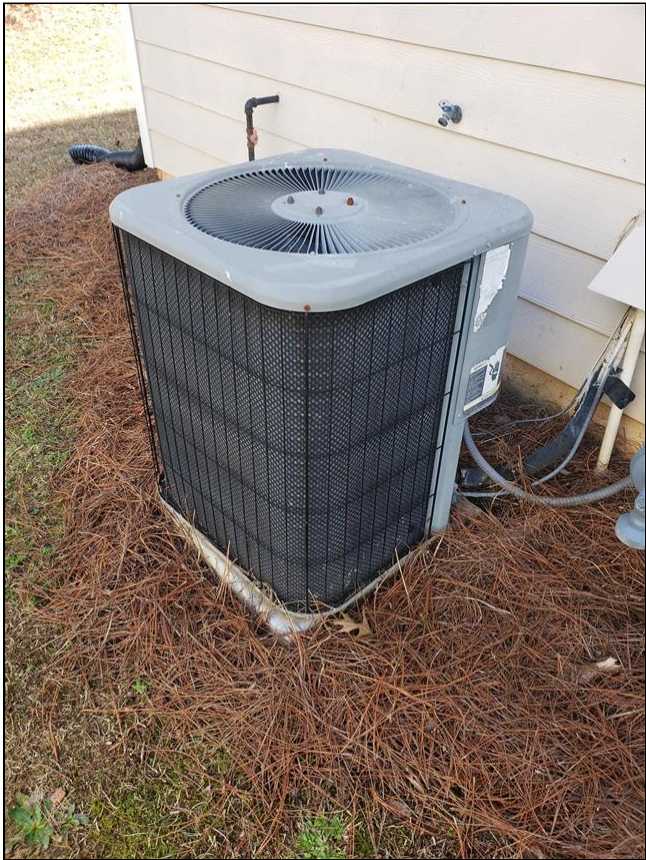
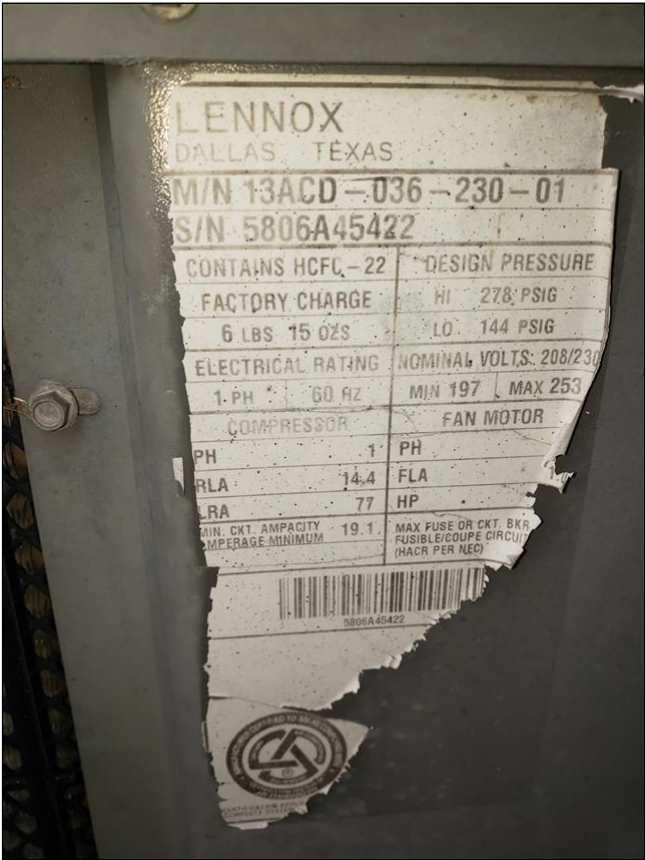
8.7 Item 1(Picture)

8.7 LENNOX AC unit has a manufacturing date of: January 2006. Although the unit is an older unit it did perform well during the inspection. I have seen units fail shortly after a home inspection during the seasonal change from mild to hot weather. I cannot determine how long your AC will last before a replacement is necessary.
