Inspection Report

Sample Report

100 Sample Report
Atlanta GA 30345

The Precise Group

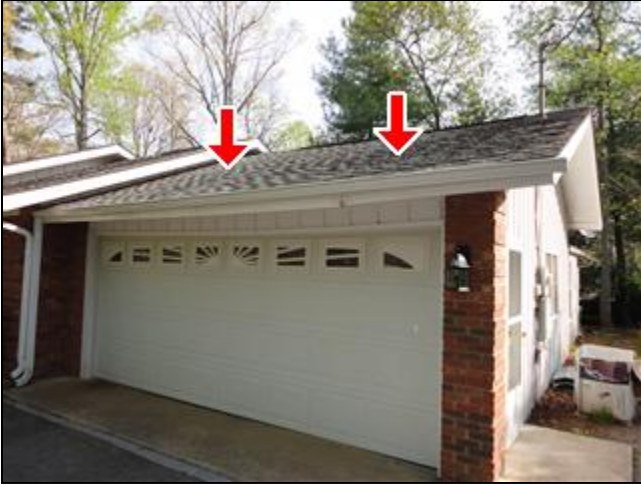
1.0 Item 1(Picture)

🔧 **1.0** (1) Evidence of a leak in the Den below corresponds with the middle skylight roof and flashing area. Repairs are needed. Recommend a qualified contractor inspect further and repair as needed.

🔧 (2) The roof covering was installed improperly above garage. Roof sheathing needs to be replaced in this area. This will involve some shingle replacement. A qualified contractor should inspect and repair as needed.

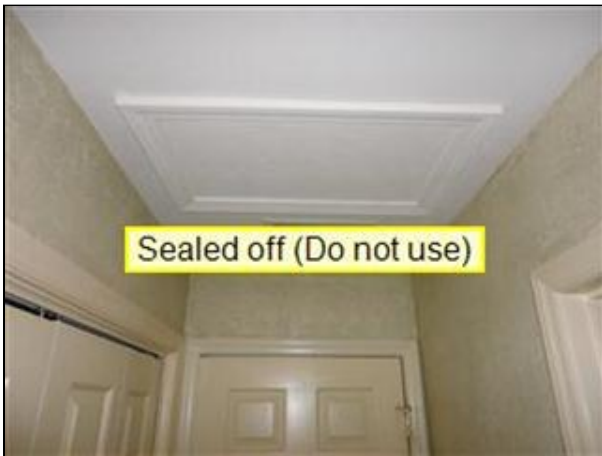
1.5 Item 1(Picture)

1.5 No longer an attic access. Use the pull down stairs at garage.

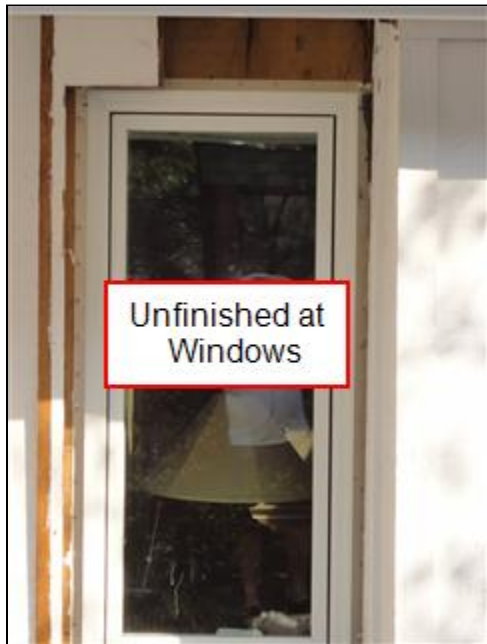
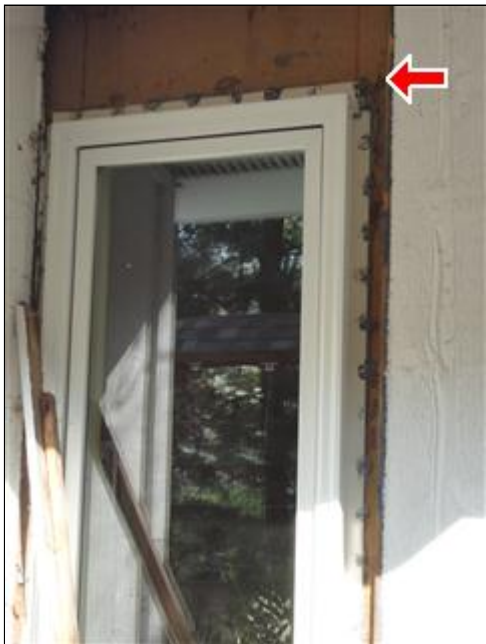
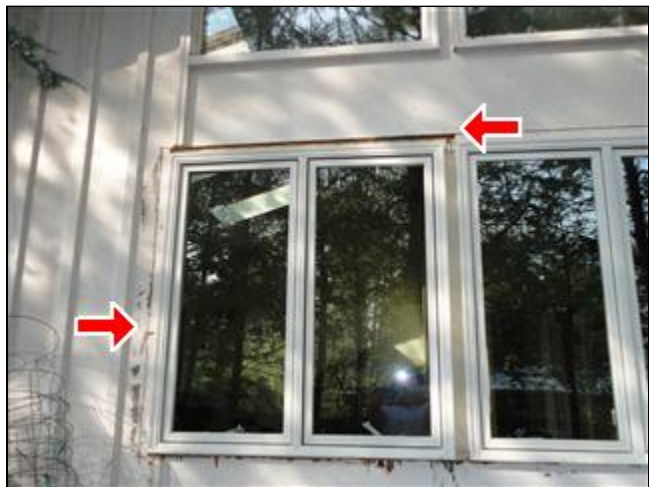
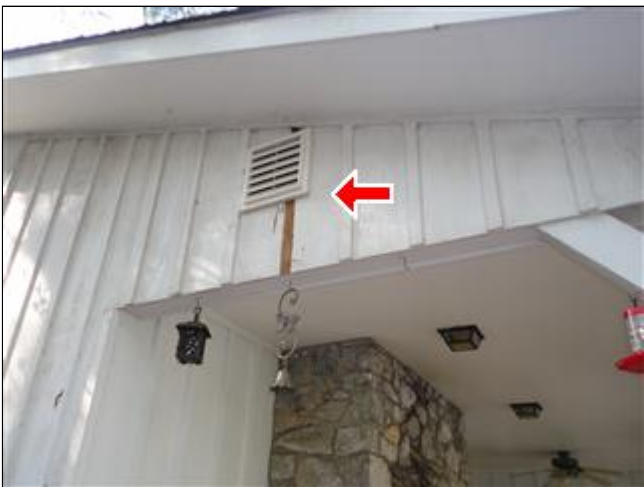
2.0 Item 1(Picture)

🔧 **2.0** The Wood siding at the right side (facing front) and rear of home is missing or incomplete at time of inspection around new premium windows that have recently been installed. I did not inspect the installation of siding at this location. A qualified contractor should inspect and repair as needed. The siding will need prep and paint.

The Wood siding at the right side (facing front) and rear of home is missing or incomplete at time of inspection around new premium windows that have recently been installed. I did not inspect the installation of siding at this location. A qualified contractor should inspect and repair as needed. The siding will need prep and paint.
- 2.4 Vegetation, Grading, Drainage, Driveways, Patio Floor, Walkways and Retaining Walls (With respect to their effect on the condition of the building)
 - Repair or Replace
 -

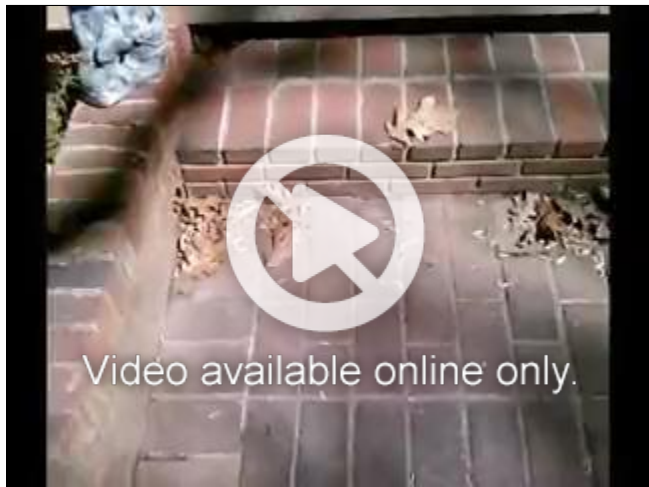
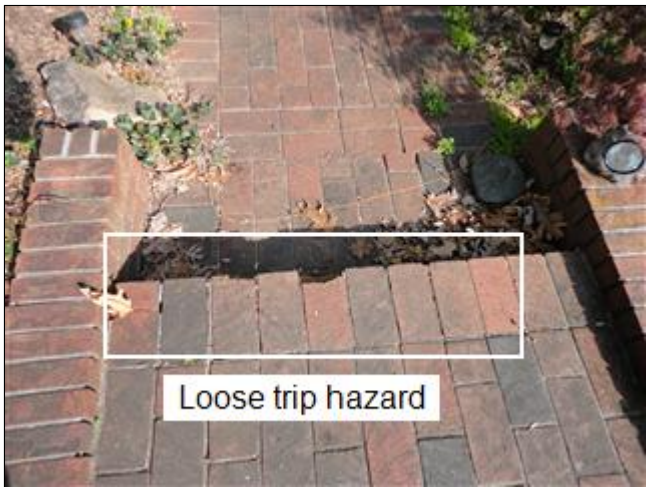
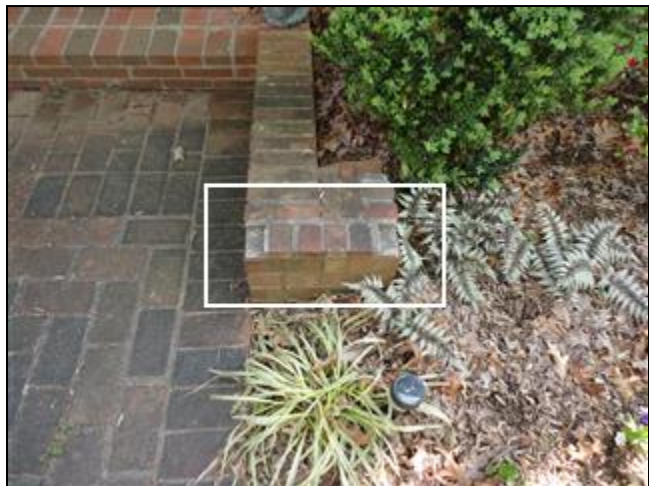
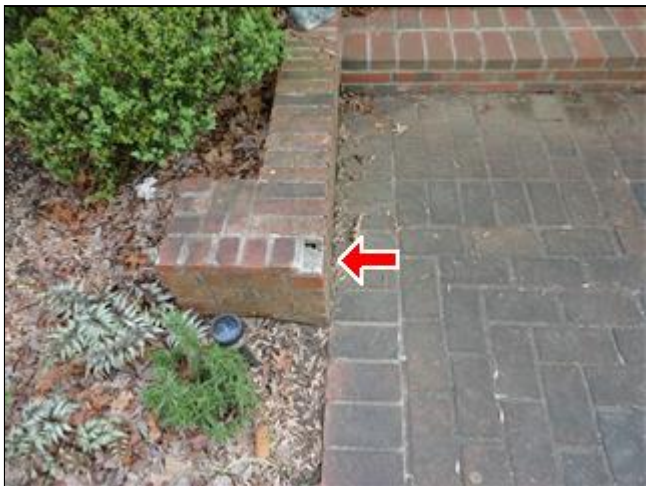
2.4 Item 2(Video) Water signs at front step

🔧 (2) The brick walkway at the front of home are deteriorated in areas. A general replacement is likely. A qualified contractor should inspect and repair as needed.

(2) The brick walkway at the front of home are deteriorated in areas. A general replacement is likely. A qualified contractor should inspect and repair as needed.

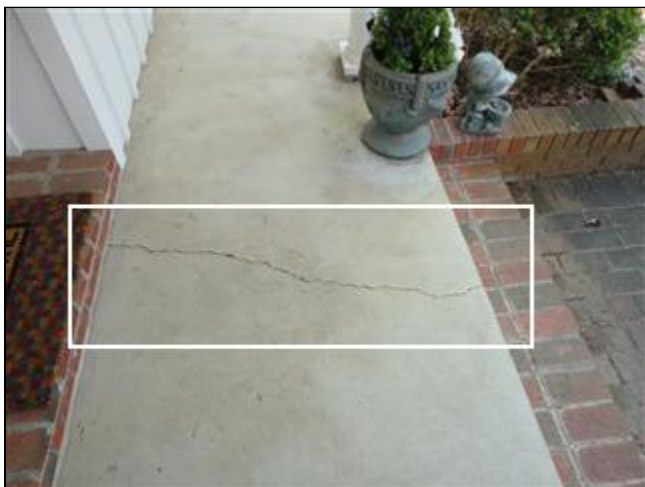
2.4 Item 6(Picture)

(3) Concrete is cracked at front entrance of home. Appears to only affect the slab itself and is more cosmetic.

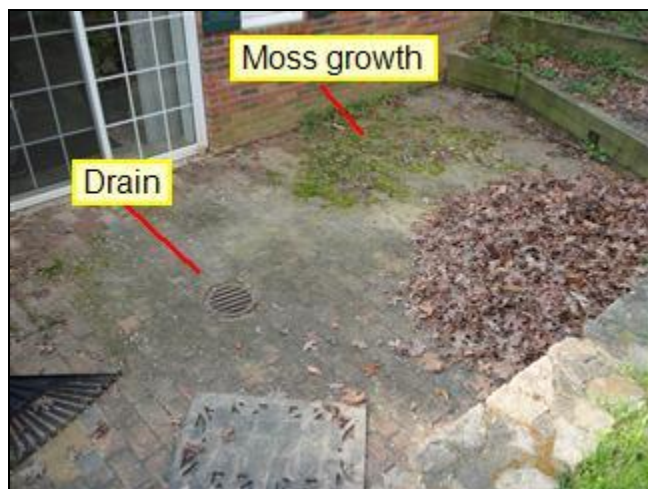
2.4 Item 7(Picture)

🔧 (4) The brick floor on the patio at the left side (facing front) has deteriorated mortar or grout, and is loose and uneven in areas. Water can cause further deterioration if not repaired and sealed properly. A qualified contractor should inspect and repair as needed.

(4) The brick floor on the patio at the left side (facing front) has deteriorated mortar or grout, and is loose and uneven in areas. Water can cause further deterioration if not repaired and sealed properly. A qualified contractor should inspect and repair as needed.
-

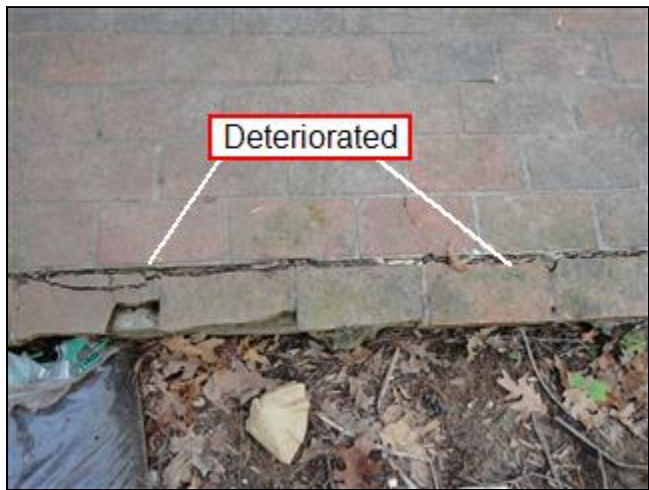
2.4 Item 8(Picture)

🔧 (5) The brick floor on the patio at the rear of home is old and deteriorated. A general replacement is likely. A qualified contractor should inspect and repair as needed.

(5) The brick floor on the patio at the rear of home is old and deteriorated. A general replacement is likely. A qualified contractor should inspect and repair as needed.

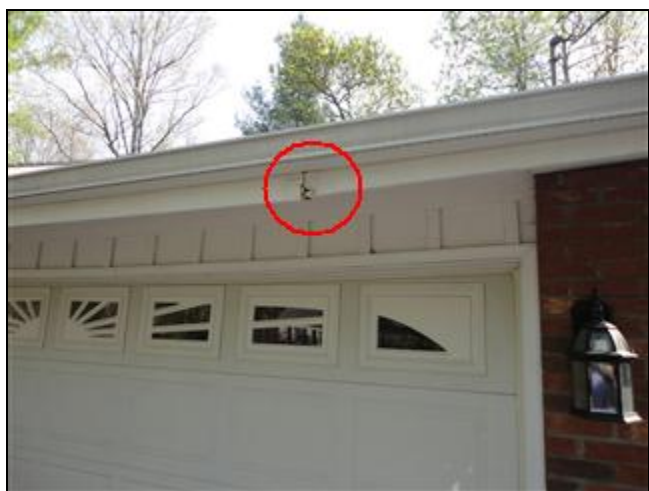
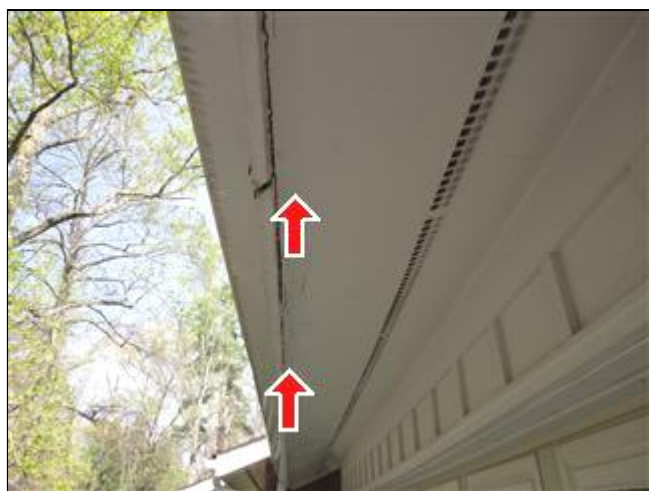
2.5 Item 1(Picture)

🔧 2.5 (1) The wood fascia and soffit panels at eave on the front of home above garage are deteriorated. Repairs are needed to roof covering as well. A qualified contractor should inspect and repair as needed.

(1) The wood fascia and soffit panels at eave on the front of home above garage are deteriorated. Repairs are needed to roof covering as well. A qualified contractor should inspect and repair as needed.
-

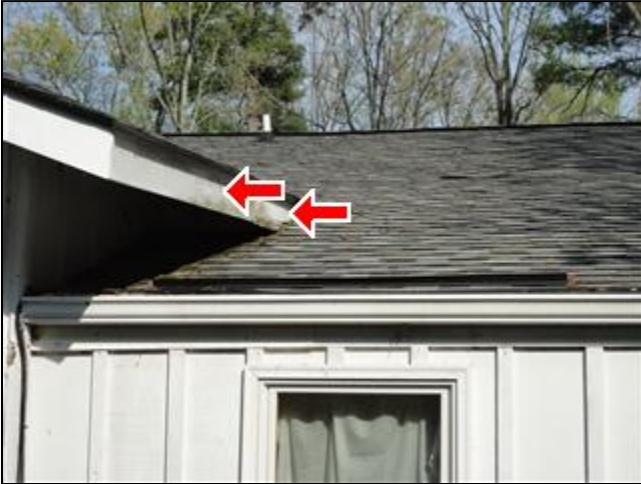
2.5 Item 3(Picture)

🔧 (2) The wood fascia at eave on the right side (facing front) is deteriorated. This is a small repair. A qualified contractor should inspect and repair as needed.

(2) The wood fascia at eave on the right side (facing front) is deteriorated. This is a small repair. A qualified contractor should inspect and repair as needed.

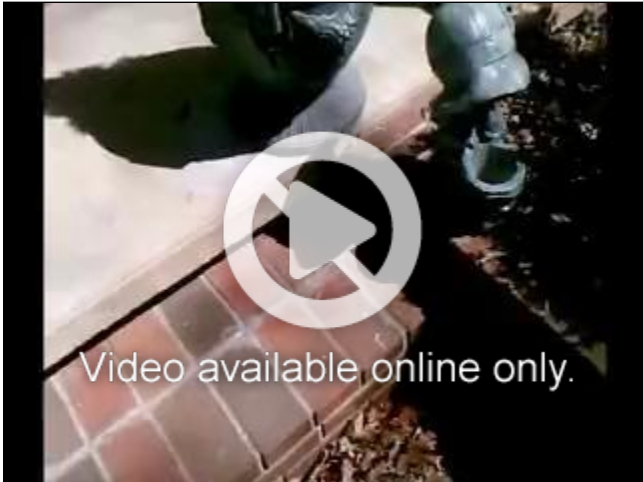
2.8 Item 1(Video)

2.8 Possible bees nest forming at right corner of front steps (see video)

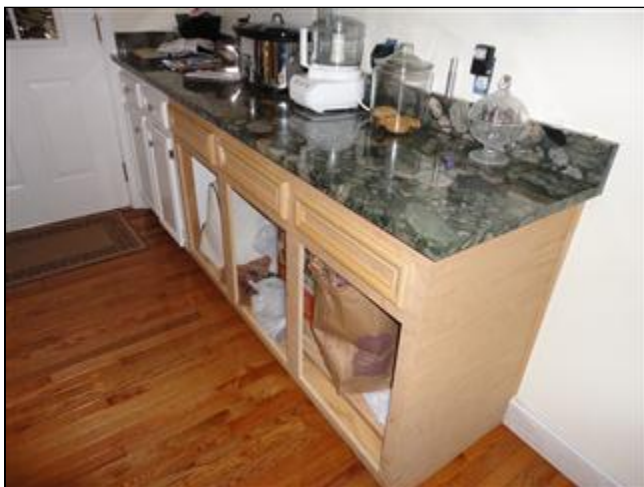
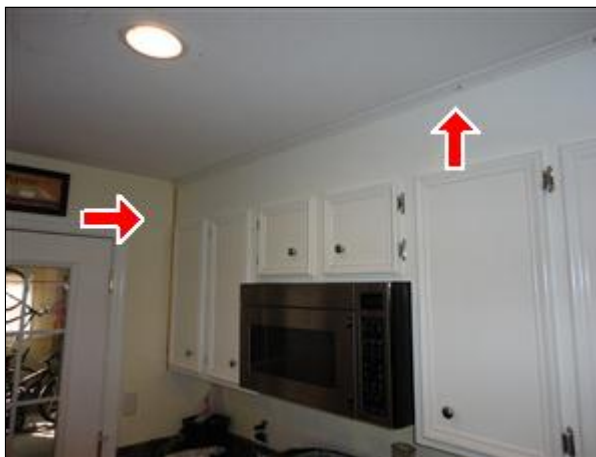
4.5 Item 1(Picture)

- 🔧 **4.5** Base Cabinetry and trim at wall cabinet are unfinished at kitchen.

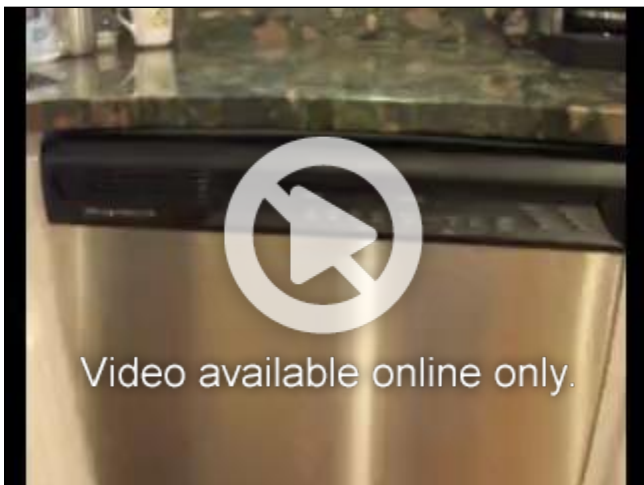
4.9 Item 1(Video)

- 🔧 **4.9** The dishwasher is loose and needs securing to underside of countertop (using a proper length screw). I recommend repair as necessary.

The dishwasher is loose and needs securing to underside of countertop (using a proper length screw). I recommend repair as necessary.

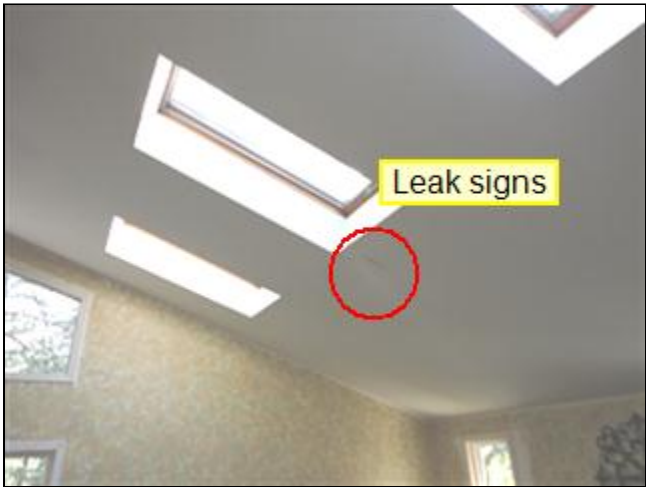
5.0 Item 1(Picture)

**5.0** (1) The Sheetrock on the ceiling reveals a water stain indicating a leak did or still exists at the Den. Repairs are needed. A qualified contractor should inspect and repair as needed (See Roof Coverings).

(1) The Sheetrock on the ceiling reveals a water stain indicating a leak did or still exists at the Den. Repairs are needed. A qualified contractor should inspect and repair as needed (See Roof Coverings).
-

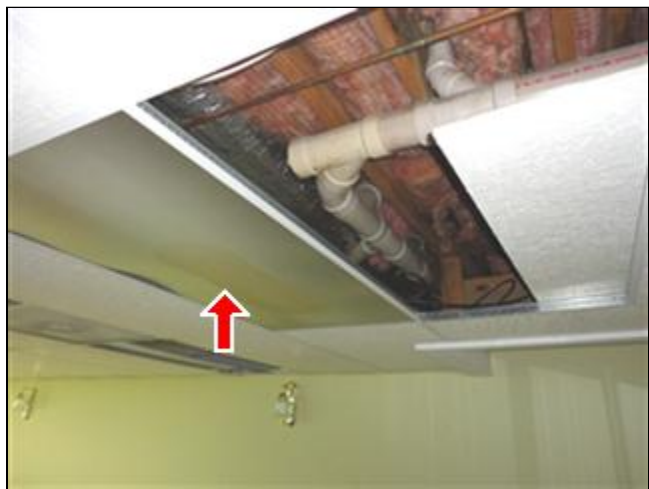
5.0 Item 2(Picture)

🔧 (2) Water stain on ceiling panel lower level indicates plumbing leak.

(2) Water stain on ceiling panel lower level indicates plumbing leak.
-

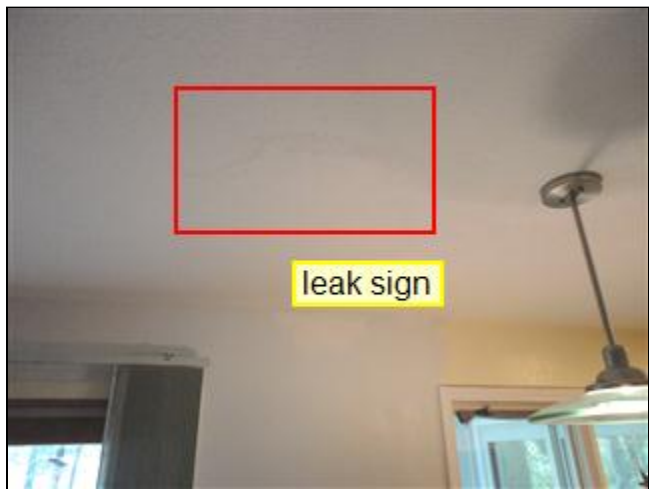
5.0 Item 3(Picture)

🔧 (3) The Drywall on the ceiling reveals a water stain indicating a leak did or still exists at the Dining Room. Repairs are needed. A qualified contractor should inspect and repair as needed.

(3) The Drywall on the ceiling reveals a water stain indicating a leak did or still exists at the Dining Room. Repairs are needed. A qualified contractor should inspect and repair as needed.

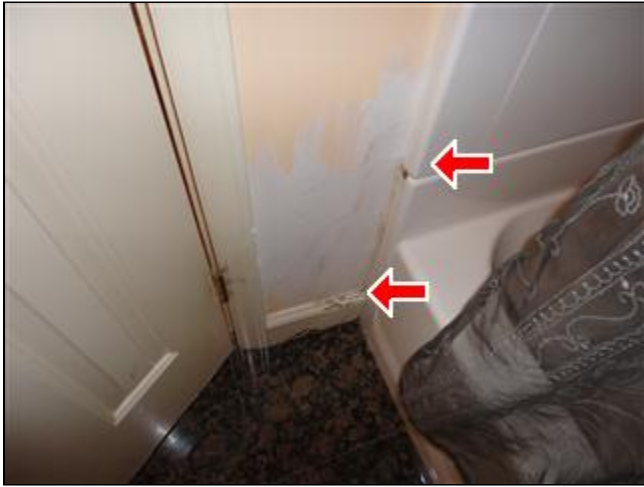
5.1 Item 1(Picture)

🔧 (2) The Wall at the bathtub is deteriorated and needs repair or replacement. The wall board and framing may need repair (not visible). I recommend repair or replace using a qualified contractor.

(2) The Wall at the bathtub is deteriorated and needs repair or replacement. The wall board and framing may need repair (not visible). I recommend repair or replace using a qualified contractor.
-

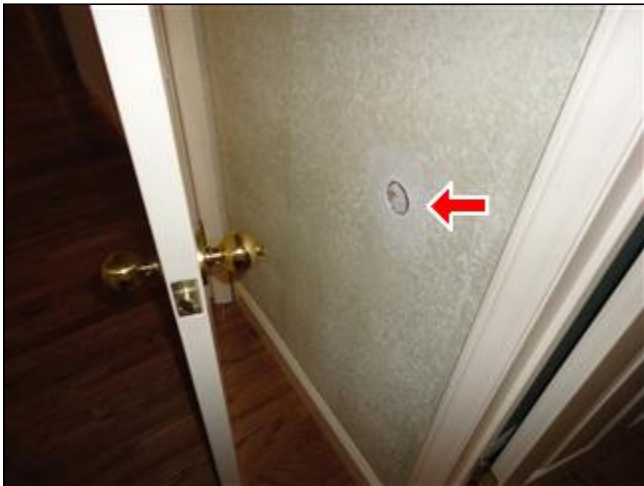
5.1 Item 2(Picture)

🔧 (3) The sheetrock on the wall is dented or damaged from door knob at the hallway. While this damage is cosmetic, it needs to be repaired. A qualified contractor should inspect and repair as needed.

(3) The sheetrock on the wall is dented or damaged from door knob at the hallway. While this damage is cosmetic, it needs to be repaired. A qualified contractor should inspect and repair as needed.
-

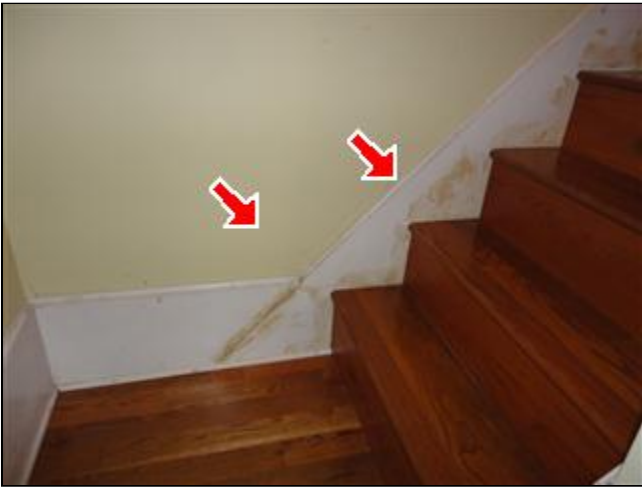
5.1 Item 3(Picture)

🔧 (4) Stair cover trim is unfinished needs prep and paint at stairs.

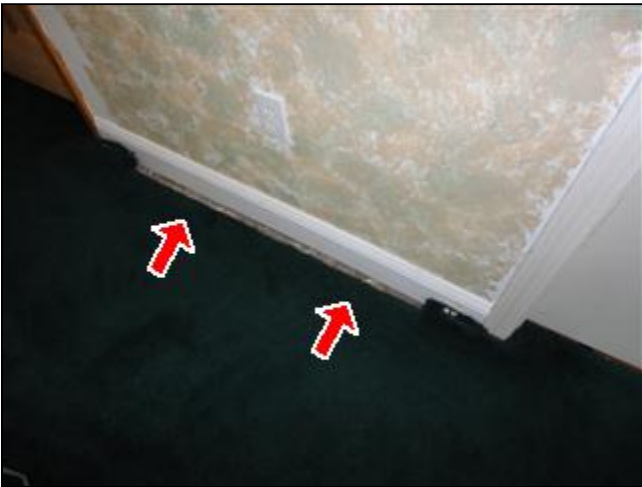
5.2 Item 1(Picture)

🔧 5.2 Carpet is loose or cut short from where electric baseboard use to be in areas around the perimeter of the Den.

Carpet is loose or cut short from where electric baseboard use to be in areas around the perimeter of the Den.

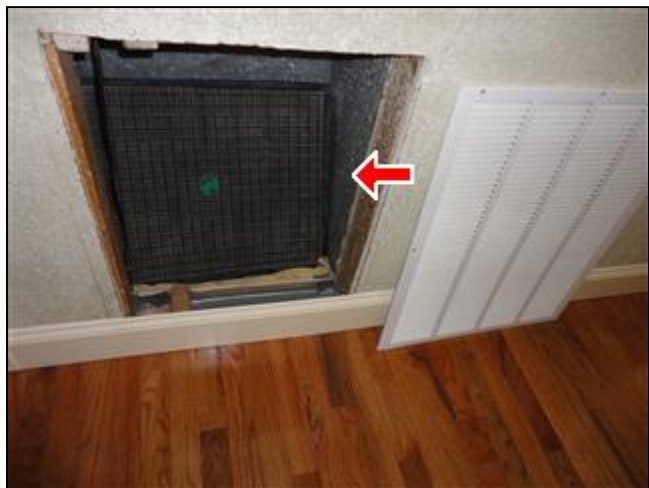
10.3 Item 1(Picture)

10.3 The washable filter is dirty. The filter needs to be cleaned. Recommend foil taping the filter for a better seal. See Video. Foam sleeve missing at suction line creates condensation and drips water.

The washable filter is dirty. The filter needs to be cleaned. Recommend foil taping the filter for a better seal. See Video. Foam sleeve missing at suction line creates condensation and drips water.

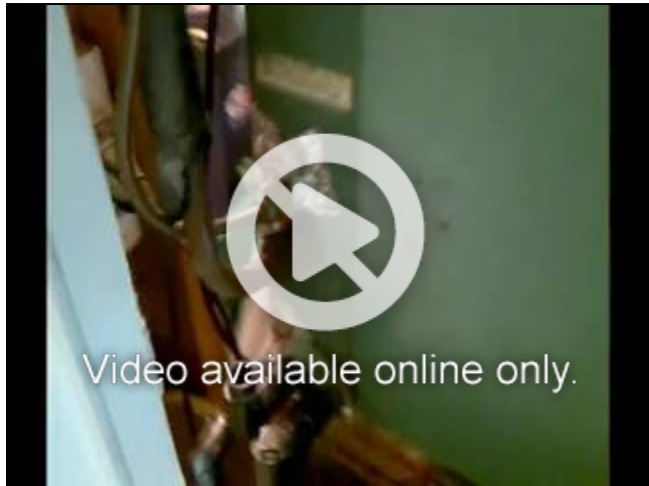
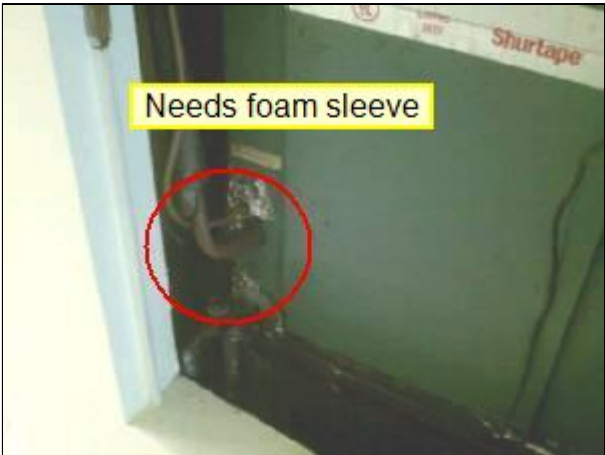
10.8 Item 1(Video)

10.8 Air handler and heat pump is old but appears to be working properly. Foam sleeve on suction line is not covering copper line and condensation can drip.
